## General Information

| Make | Toyota | Model | Ativ |
| Registration No. | DCE9791 | Chassis No. | MR2BE9B3XS0140347 |

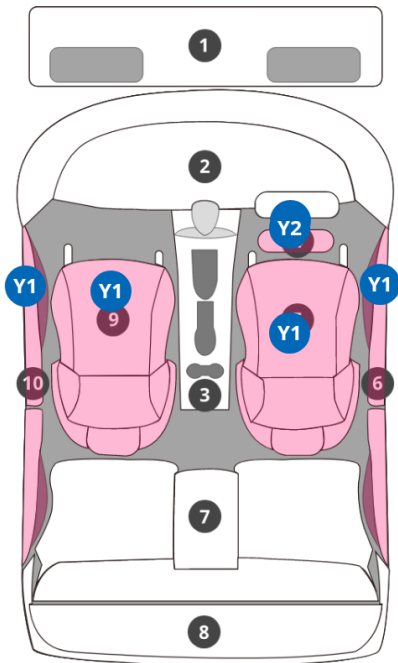
| Interior Evaluation : <span style="color: red;">A</span> | Exterior Evaluation : <span style="color: red;">C</span> |
|---|---|
| <b>Remarks</b><br>(L) Front Seat - Grime - Minimal / (R) Front Seat - Grime - Minimal / (L) Front Floor Mat - Grime - Minimal / (R) Front Floor Mat - Grime - Small / (L) Front Trim - Grime - Minimal / (R) Front Trim - Grime - Minimal | <b>Remarks</b><br>Roof - Repair Traces - Yes / Front Bumper, Grille, Lamps - Crack, Gap - Medium / Bonnet, Headlight - Dent - Medium / Trunk Hood, Rear Gate - Scratch & Dent - Minimal / (R) Rear Fender, Molding - Scratch - Minimal / Roof - Scratch - Small / (L) Rear Fender, Molding - Scratch - Small / (L) Rear Door, Molding - Scratch & Dent - Minimal / (L) Step, In-panel, Side Spoiler - Scratch - Minimal / (L) Front Door, Molding - Scratch & Dent - Minimal / (L) Front Fender, Molding - Scratch & Dent - Minimal / Front Bumper, Grille, Lamps - Repair mark - Yes / (R) Front Fender, Molding - Scratch & Dent - Small / (R) Front Door, Molding - Scratch - Small / (R) Rear Door, Molding - Scratch & Dent - Minimal / (R) Step, In-panel, Side Spoiler - Scratch - Minimal / Rear Bumper, Lamps, Panels - Scratch - Minimal |
