## General Information

| Make | Mitsubishi | Model | Xpander Cross |
| Registration No. | FAO2828 | Chassis No. | MK2XRNC1WPN000954 |

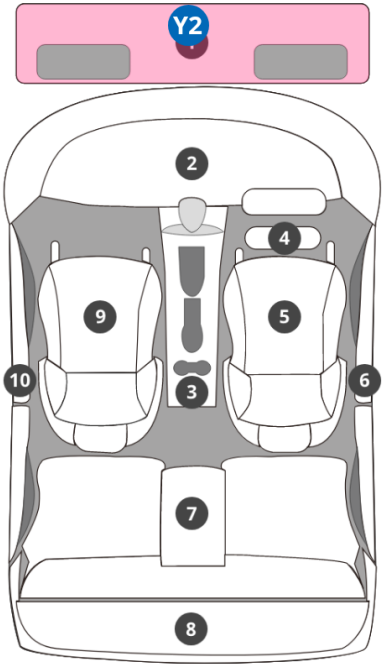
| <b>Interior Evaluation :</b> <span style="color: red; font-weight: bold;">A</span> | <b>Exterior Evaluation :</b> <span style="color: red; font-weight: bold;">D</span> |
| <b>Remarks</b><br>Ceiling - Grime - Small | <b>Remarks</b><br>(R) Front Door - Repair Traces - Yes / (R) Step - Repair Traces - Yes / (R) Front Fender - Repair Traces - Yes / Bonnet - Repair Traces - Yes / (L) Front Fender - Repair Traces - Yes / (L) Rear Door - Repair Traces - Yes / (L) Rear Fender - Repair Traces - Yes / Trunk Hood, Rear Gate - Repair Traces - Yes / (R) Rear Fender - Repair Traces - Yes / (R) Rear Door - Repair Traces - Yes / Roof - Repair Traces - Yes / (R) Front Fender, Molding - Repair mark - Yes / (R) Front Door, Molding - Scratch - Large / (R) Rear Door, Molding - Scratch - Large / (R) Rear Fender, Molding - Scratch & Dent - Large / Rear Bumper, Lamps, Panels - Scratch & Dent - Small / (L) Rear Fender, Molding - Repair mark - Yes / (L) Rear Door, Molding - Scratch - Small / (L) Front Door, Molding - Scratch - Small / (L) Front Fender, Molding - Repair mark - Yes / Front Bumper, Grille, Lamps - Scratch - Minimal / Roof Spoiler, Molding - Scratch & Dent - Small / Trunk Hood, Rear Gate - Dent - Small |
