## General Information

| Make | Toyota | Model | Hilux |
| YOM | 2022 | Odo Meter Reading | 166,257 |
| Registration No. | CAW5528 | Chassis No. | MR0CB8CB0M4272602 |

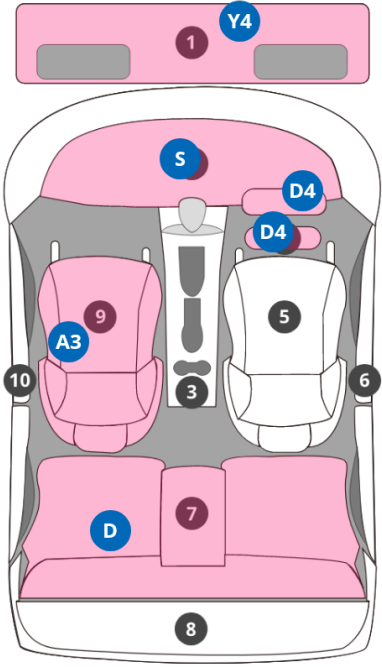
| Interior Evaluation : <span style="color: red;">C</span> | Exterior Evaluation : <span style="color: red;">E</span> |
| <p><b>Remarks</b></p> <p>Rear Seat - Worn - Yes / Instrument Panel - Loose, Deformed - Large / (L) Front Seat - Cut, Crack - Medium / (L) Front Floor Mat - Worked - Large / Overall Interior - Worn as per age - Yes / Overall Interior - Smell - Yes / Ceiling - Grime - Large</p> | <p><b>Remarks</b></p> <p>(R) Front Door - Repair Traces - Yes / (R) Step - Repair Traces - Yes / (R) Front Fender - Repair Traces - Yes / (L) Front Door - Repair Traces - Yes / (L) Step - Repair Traces - Yes / (L) Rear Corner Panel - Repair Traces - Yes / Roof - Repair Traces - Yes / (L) Side Gate - Scratch &amp; Dent - Large / (L) Guard Frame - Scratch &amp; Dent - Large / Rear Windshield - Damaged - Large / Rear Gate - Scratch &amp; Dent - Large / Rear Bumper, Lamps, Panels - Scratch &amp; Dent - Large / (R) Guard Frame - Scratch &amp; Dent - Large / (R) Side Gate - Scratch &amp; Dent - Large / (R) Front Door, Molding - Scratch &amp; Dent - Large / (R) Step, In-panel, Side Spoiler - Scratch &amp; Dent - Medium / (R) Front Fender, Molding - Scratch &amp; Dent - Large / Front Bumper, Grille, Lamps - Scratch &amp; Dent - Large / Bonnet, Headlight - Scratch &amp; Dent - Medium / (L) Step, In-panel, Side Spoiler - Scratch - Large / Roof - Scratch &amp; Dent - Large</p> |
