## General Information

| Make | Toyota | Model | Hilux Tamaraw |
| Registration No. | NEZ9747 | Chassis No. | PAHACACA8S6430659 |

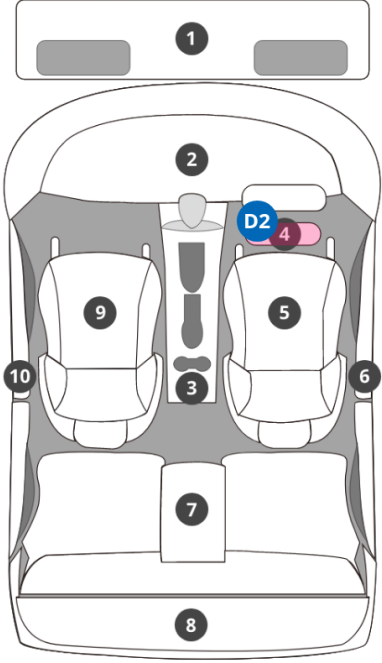
| Interior Evaluation : <span style="color: red; font-weight: bold;">A</span> | Exterior Evaluation : <span style="color: red; font-weight: bold;">D</span> |
| <b>Remarks</b><br>(L) Front Floor Mat - Worked - Small | <b>Remarks</b><br>Front Bumper, Grille, Lamps - Scratch - Medium / (R) Guard Frame - Scratch & Dent - Large / Cargo Bed Floor - Scratch & Dent - Large / Rear Gate - Scratch - Medium / (L) Side Gate - Crack, Gap - Large / Roof - Scratch - Medium / Rear Bumper, Lamps, Panels - Scratch - Large |
