## General Information

| Make | Toyota | Model | Hilux Tamaraw |
| YOM | 2026 | Odo Meter Reading | 14,501 |
| Registration No. | DCE3936 | Chassis No. | PAHACACA3S6431685 |

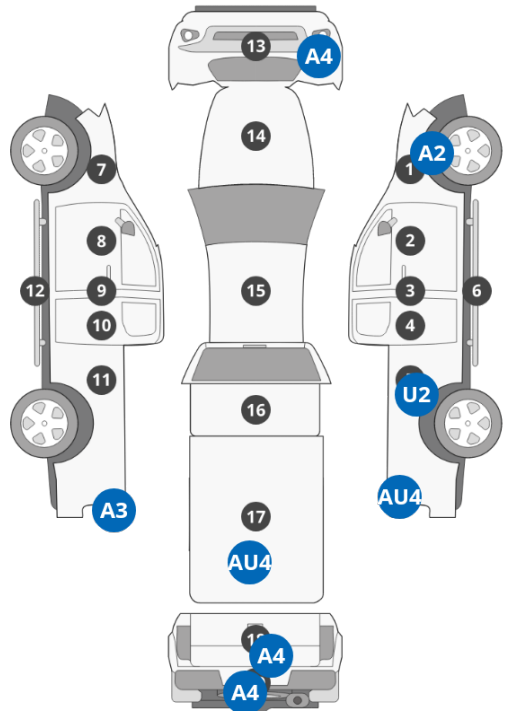
| Interior Evaluation : <span style="color: red; font-weight: bold;">A</span> | Exterior Evaluation : <span style="color: red; font-weight: bold;">D</span> |
|---|---|
| <b>Remarks</b><br>Defects not found | <b>Remarks</b><br>(R) Guard Frame - Scratch & Dent - Large / Rear Gate - Scratch - Large / Rear Bumper, Lamps, Panels - Scratch - Large / Cargo Bed Floor - Scratch & Dent - Large / (L) Guard Frame - Scratch - Medium / Front Bumper, Grille, Lamps - Scratch - Large / (R) Front Fender, Molding - Scratch - Small |

no jack and tools/ light scratches around the exterior / with LTO plate and warranty booklet/ with spare tire/
