## General Information

| Make | Suzuki | Model | Ertiga |
| Registration No. | DNV3612 | Chassis No. | MHYNC32S1RJ105114 |

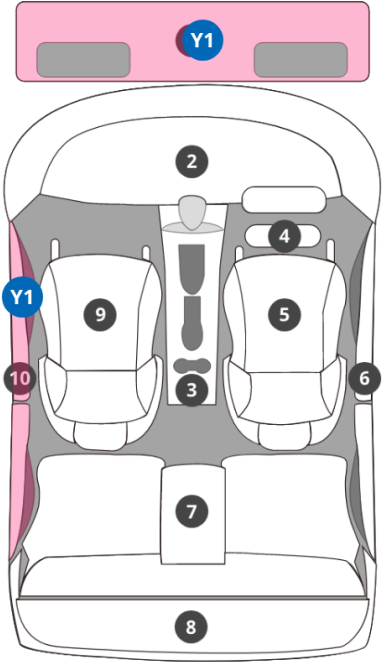
| Interior Evaluation : <span style="color: red; font-weight: bold;">A</span> | Exterior Evaluation : <span style="color: red; font-weight: bold;">B</span> |
|---|---|
| <b>Remarks</b><br>Ceiling - Grime - Minimal / (L) Front Trim - Grime - Minimal | <b>Remarks</b><br>(L) Front Fender - Repair Traces - Yes / Bonnet, Headlight - Scratch - Small / Front Bumper, Grille, Lamps - Scratch - Small / (L) Front Door, Molding - Scratch & Dent - Minimal / (L) Step, In-panel, Side Spoiler - Scratch & Dent - Minimal / (L) Rear Door, Molding - Scratch - Minimal / (L) Rear Fender, Molding - Scratch - Minimal / (R) Rear Fender, Molding - Scratch - Small / (R) Rear Door, Molding - Scratch & Dent - Minimal / (R) Front Door, Molding - Scratch & Dent - Minimal / (R) Step, In-panel, Side Spoiler - Scratch - Minimal / Roof - Scratch - Small / Rear Bumper, Lamps, Panels - Scratch - Small / Trunk Hood, Rear Gate - Scratch & Dent - Minimal / (R) Front Fender, Molding - Scratch - Minimal / (L) Front Fender, Molding - Scratch & Dent - Minimal |
