## General Information

<b>Make</b>	Toyota	<b>Model</b>	Wigo
<b>YOM</b>	2025	<b>Odo Meter Reading</b>	13,174
<b>Registration No.</b>	GBJ5962	<b>Chassis No.</b>	MHKAA1BC0SJ036062
<b>CC</b>	1.0	<b>Transmission</b>	CVT
<b>Fuel Type</b>	Gas	<b>Type of Body</b>	Hatchback
<b>Colour</b>	Gray

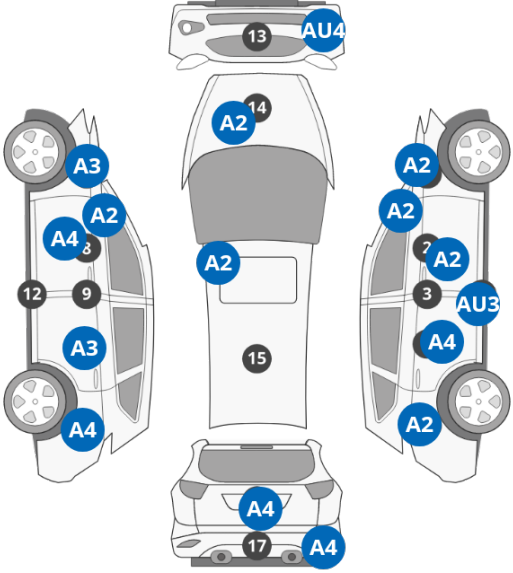
<p><b>A</b> : Scratch <b>AU</b> : Scratch &amp; Dent <b>B</b> : Modified <b>C</b> : Corrosion <b>G</b> : Stone chip <b>P</b> : Faded <b>S</b> : Rust <b>SC</b> : Rust &amp; Corrosion <b>U</b> : Dent <b>X</b> : Defective <b>Y</b> : Crack, Gap</p>
<p><b>Remarks</b> (L) Front Floor Mat - Grime - Small / Dashboard - Traces of Adhesive Tape - Yes / Sunvisor, Sunglass Holder - Crinkle - Small / Ceiling - Grime - Small / (R) Front Floor Mat - Grime - Medium / Mat Other - Grime - Small</p>	<p><b>Remarks</b> (L) Front Fender, Molding - Scratch - Medium / (L) Mirror - Scratch - Small / (L) Front Door, Molding - Scratch - Large / (L) Rear Door, Molding - Scratch - Medium / (L) Rear Fender, Molding - Scratch - Large / Trunk Hood, Rear Gate - Scratch - Large / Rear Bumper, Lamps, Panels - Scratch - Large / (R) Rear Fender, Molding - Scratch - Small / (R) Rear Door, Molding - Scratch - Large / (R) Front Door, Molding - Scratch - Small / (R) Step, In-panel, Side Spoiler - Scratch &amp; Dent - Medium / (R) Mirror - Scratch - Small / (R) Front Fender, Molding - Scratch - Small / Bonnet, Headlight - Scratch - Small / Front Bumper, Grille, Lamps - Scratch &amp; Dent - Large / Roof - Scratch - Small</p>
