## General Information

| Make | Toyota | Model | Vios |

## Body / Panel Condition

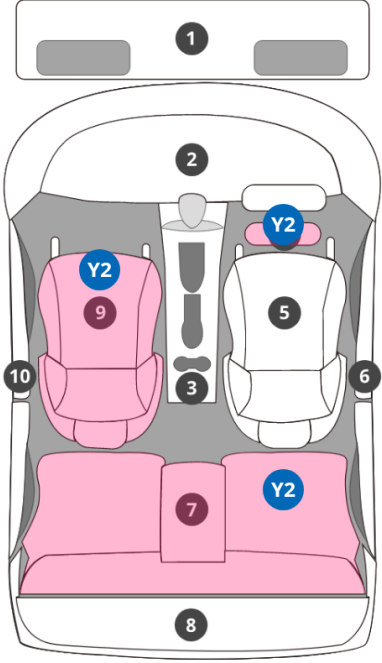
| Interior Evaluation : <b>A</b> | Exterior Evaluation : <b>B</b> |
|---|---|
| <p><b>Remarks</b><br/>(L) Front Seat - Grime - Small / (L) Front Floor Mat - Grime - Small / Rear Seat - Grime - Small</p> | <p><b>Remarks</b><br/>Rear Bumper, Lamps, Panels - Scratch - Small / (R) Front Fender, Molding - Scratch - Medium / Front Bumper, Grille, Lamps - Scratch - Small / (L) Front Door, Molding - Dent - Minimal / Roof - Dent - Small / (L) Rear Fender, Molding - Dent - Minimal</p> |

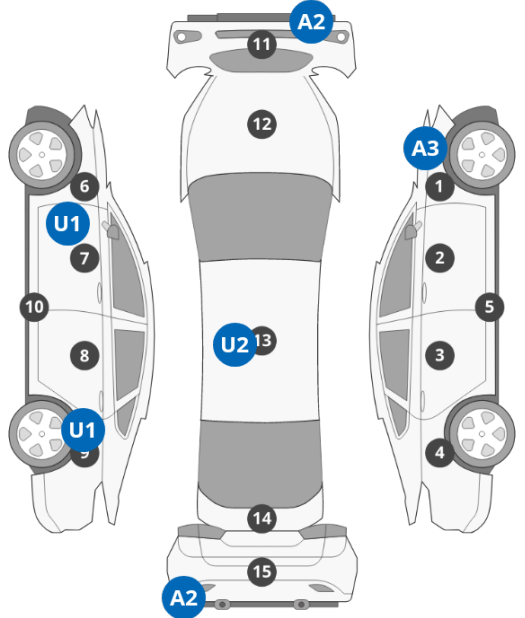
| Inspector Notes |
|---|
| with LTO plate/with spare tire/with jack and tools/with warranty booklet/ left tail light crack |
