## General Information

| Make | Honda | Model | City |
| YOM | 2018 | Odo Meter Reading | 97,806 |
| Registration No. | DAG1452 | Chassis No. | PADGM6630JV414157 |

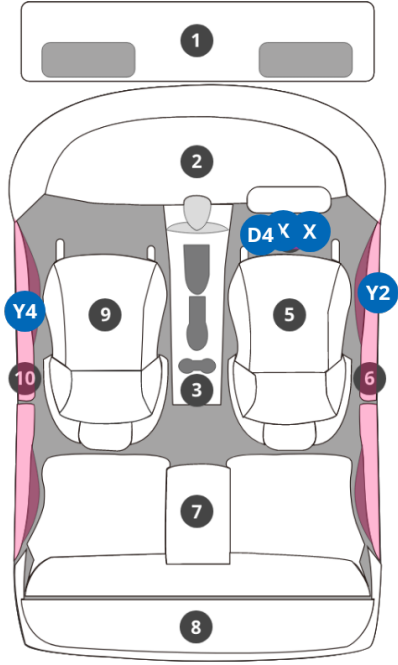
| Interior Evaluation : <b>C</b> | Exterior Evaluation : <b>E</b> |
| <p><b>Remarks</b></p> <p>Mat Other - Missing - Yes / (R) Front Floor Mat - Missing - Yes / (L) Front Floor Mat - Crinkle - Large / Overall Interior - Worn as per age - Yes / (L) Front Trim - Grime - Large / (R) Front Trim - Grime - Small</p> | <p><b>Remarks</b></p> <p>(L) Step - Repair Traces - Yes / (L) Rear Door - Repair Traces - Yes / (L) Rear Fender - Repair Traces - Yes / Trunk Hood, Rear Gate - Repair Traces - Yes / Front Bumper, Grille, Lamps - Scratch &amp; Dent - Large / (L) Front Fender, Molding - Crack, Gap - Medium / (L) Step, In-panel, Side Spoiler - Scratch &amp; Dent - Medium / (L) Rear Door, Molding - Scratch &amp; Dent - Small / (L) Front Door, Molding - Scratch - Small / (L) Rear Fender, Molding - Repair mark - Yes / Trunk Hood, Rear Gate - Scratch &amp; Dent - Large / Rear Bumper, Lamps, Panels - Repair mark - Yes / Front Bumper, Grille, Lamps - Repair mark - Difference in Color / Rear Bumper, Lamps, Panels - Scratch &amp; Dent - Large / (R) Rear Fender, Molding - Scratch - Small / (R) Rear Door, Molding - Scratch - Small / (R) Front Door, Molding - Scratch &amp; Dent - Small / (R) Front Fender, Molding - Crack, Gap - Large / Bonnet, Headlight - Crack, Gap - Medium / (R) Mirror - Scratch - Small / (L) Mirror - Scratch - Medium / Roof - Scratch &amp; Dent - Small</p> |
