## General Information

| Make | Mitsubishi | Model | Mirage |

## Body / Panel Condition

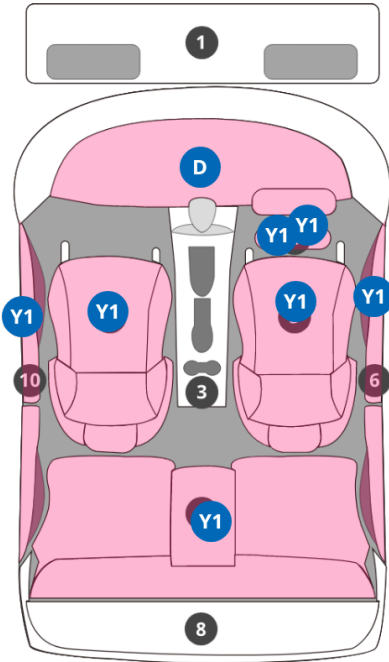
| Interior Evaluation : <span style="color: red; font-weight: bold;">A</span> | | Exterior Evaluation : <span style="color: red; font-weight: bold;">C</span> | |
|---|--|---|--|
| <p><b>Remarks</b></p> <p>(L) Front Seat - Grime - Minimal / (R) Front Seat - Grime - Minimal / Rear Seat - Grime - Minimal / (L) Front Floor Mat - Grime - Minimal / (R) Front Floor Mat - Grime - Minimal / (L) Front Trim - Grime - Minimal / (R) Front Trim - Grime - Minimal / Dashboard - Traces of Adhesive Tape - Yes</p> | | <p><b>Remarks</b></p> <p>Roof - Scratch &amp; Dent - Minimal / (L) Front Door, Molding - Scratch &amp; Dent - Minimal / (L) Rear Door, Molding - Modified - Minimal / (L) Rear Fender, Molding - Scratch &amp; Dent - Minimal / Trunk Hood, Rear Gate - Scratch &amp; Dent - Minimal / (R) Rear Fender, Molding - Scratch - Minimal / Rear Bumper, Lamps, Panels - Scratch - Small / (R) Rear Door, Molding - Scratch - Small / (R) Step, In-panel, Side Spoiler - Scratch - Medium / (R) Front Door, Molding - Scratch - Small / (R) Front Fender, Molding - Scratch &amp; Dent - Minimal / Bonnet, Headlight - Scratch &amp; Dent - Minimal / (L) Front Fender, Molding - Scratch &amp; Dent - Minimal / (L) Step, In-panel, Side Spoiler - Scratch - Small / Front Bumper, Grille, Lamps - Scratch - Small</p> | |

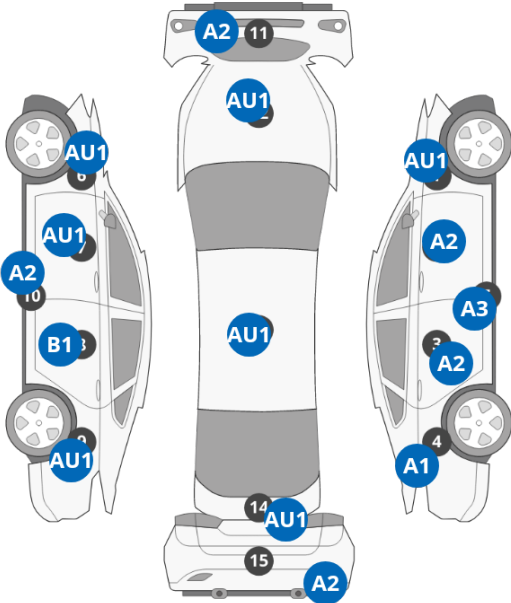
with LTO plate, with spare tire, with jack and incomplete tools, no spare key, no warranty and manual booklet, no reverse camera, minor scratches and dent on exterior, scratches in taillight and headlight.
