## General Information

| Make | Toyota | Model | Veloz |
| Registration No. | DBS4022 | Chassis No. | MHFAB1BY9R3119771 |

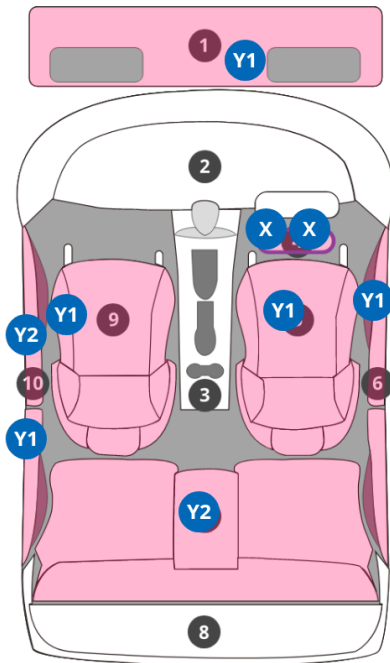
| Interior Evaluation : <b>B</b> | Exterior Evaluation : <b>B</b> |
| <p><b>Remarks</b></p> <p>Rear Seat - Grime - Small / (R) Front Seat - Grime - Minimal / (R) Front Floor Mat - Missing - Yes / (R) Front Trim - Grime - Minimal / (L) Rear Trim - Grime - Minimal / (L) Front Trim - Grime - Small / (L) Front Floor Mat - Missing - Yes / (L) Front Seat - Grime - Minimal / Ceiling - Grime - Minimal</p> | <p><b>Remarks</b></p> <p>(L) Front Fender, Molding - Scratch - Minimal / (L) Front Door, Molding - Scratch - Minimal / (L) Step, In-panel, Side Spoiler - Scratch - Small / (L) Rear Door, Molding - Scratch - Minimal / (L) Rear Fender, Molding - Scratch - Minimal / Trunk Hood, Rear Gate - Scratch - Minimal / Rear Bumper, Lamps, Panels - Scratch - Small / (R) Rear Fender, Molding - Scratch - Minimal / (R) Rear Door, Molding - Scratch - Minimal / (R) Step, In-panel, Side Spoiler - Scratch - Small / (R) Front Door, Molding - Scratch - Minimal / (R) Front Fender, Molding - Scratch &amp; Dent - Small / Front Bumper, Grille, Lamps - Scratch - Small / Bonnet, Headlight - Scratch - Minimal / Roof - Scratch - Small</p> |

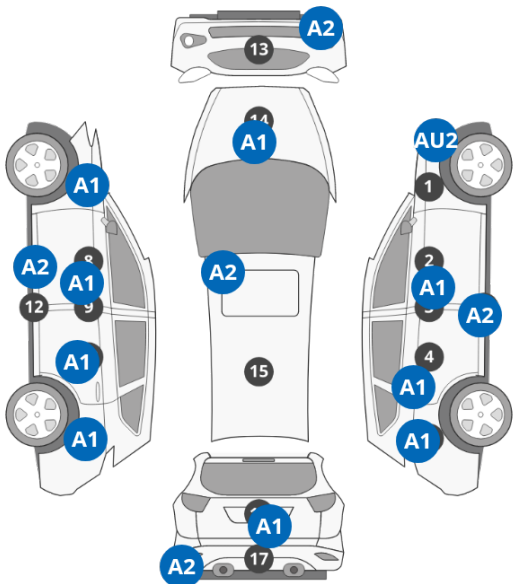
with LTO plate/with warranty booklet/with tools and jack/with spare tire/no spare key/maintenance warning lamp on/hairline scratches on the body/possible pest inside
