## General Information

| Make | Mitsubishi | Model | Xpander Cross |

## Body / Panel Condition

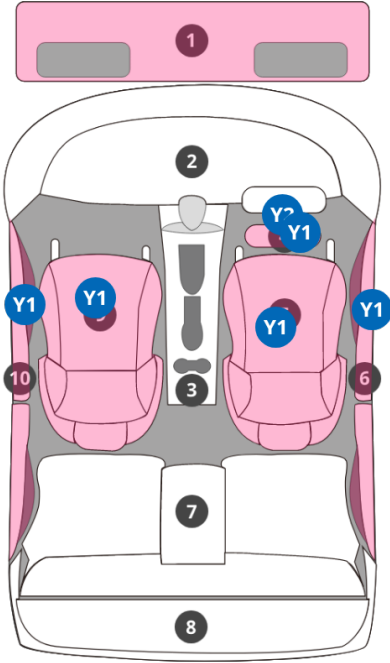
| Interior Evaluation : <b>B</b> | Exterior Evaluation : <b>E</b> |
| <p><b>Remarks</b><br/>(L) Front Floor Mat - Grime - Small / (R) Front Floor Mat - Grime - Minimal / (L) Front Seat - Grime - Minimal / (R) Front Seat - Grime - Minimal / (L) Front Trim - Grime - Minimal / (R) Front Trim - Grime - Minimal / Switches - Missing - Yes</p> | <p><b>Remarks</b><br/>(R) Front Fender - Repair Traces - Yes / Bonnet - Repair Traces - Yes / (L) Front Fender - Repair Traces - Yes / Roof - Scratch &amp; Dent - Small / (L) Rear Fender, Molding - Scratch - Small / (L) Rear Door, Molding - Scratch &amp; Dent - Small / (L) Front Door, Molding - Scratch &amp; Dent - Minimal / (L) Step, In-panel, Side Spoiler - Scratch - Small / (L) Front Fender, Molding - Scratch - Small / Front Bumper, Grille, Lamps - Crack, Gap - Medium / (R) Front Fender, Molding - Crack, Gap - Large / Bonnet, Headlight - Scratch &amp; Dent - Minimal / (R) Front Door, Molding - Scratch &amp; Dent - Small / (R) Rear Door, Molding - Scratch - Large / (R) Rear Fender, Molding - Scratch &amp; Dent - Small / Trunk Hood, Rear Gate - Dent - Medium / Rear Bumper, Lamps, Panels - Scratch - Small</p> |

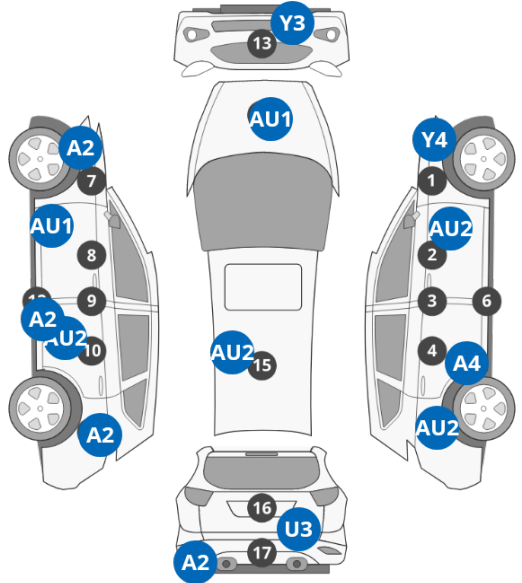
| Inspector Notes |
|---|
| with LTO plate,with jack, with reverse camera, with warranty booklet, no spare key, no manual booklet, issue in headlight and taillight crack lens, issue in dash indicator lamp on,scratches and dent on exterior, scratches in taillight and headlight. |
