## General Information

| Make | Mitsubishi | Model | Mirage |
| Registration No. | NLA5898 | Chassis No. | PAEA13RXTSA002487 |

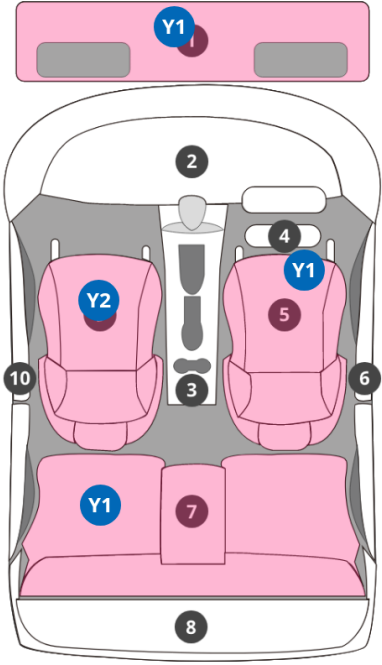
| Interior Evaluation : <span style="color: red; font-weight: bold;">A</span> | Exterior Evaluation : <span style="color: red; font-weight: bold;">B</span> |
|---|---|
| <b>Remarks</b><br>(L) Front Seat - Grime - Small / (R) Front Seat - Grime - Minimal / Ceiling - Grime - Minimal / Rear Seat - Grime - Minimal | <b>Remarks</b><br>Roof - Scratch & Dent - Minimal / (R) Rear Fender, Molding - Scratch - Minimal / (R) Rear Door, Molding - Scratch - Minimal / (R) Front Door, Molding - Scratch & Dent - Minimal / (R) Front Fender, Molding - Scratch - Minimal / Bonnet, Headlight - Scratch & Dent - Minimal / (L) Front Fender, Molding - Scratch - Minimal / (L) Front Door, Molding - Scratch - Small / (L) Rear Door, Molding - Scratch & Dent - Minimal / (L) Rear Fender, Molding - Scratch & Dent - Minimal / Trunk Hood, Rear Gate - Scratch & Dent - Minimal / Rear Bumper, Lamps, Panels - Scratch - Minimal / (R) Step, In-panel, Side Spoiler - Scratch & Dent - Minimal / Front Bumper, Grille, Lamps - Scratch - Small |

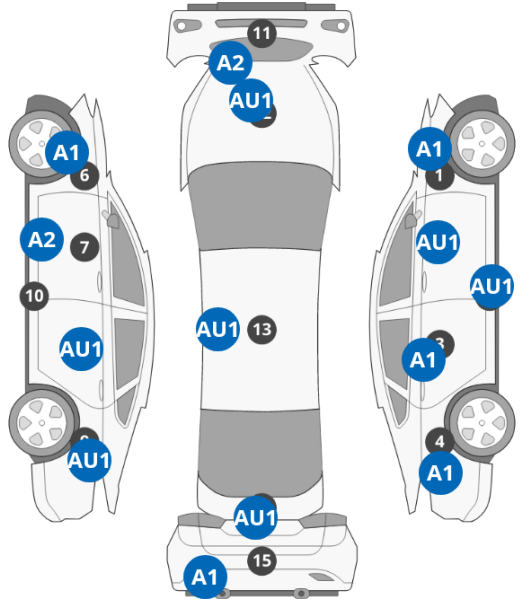
with LTO plate, with spare tire and key, with jack and inc tools, with reverse camera, no warranty and manual booklet, minor scratches on exterior, minor scratches in taillight and headlight.
