## General Information

| Make | Toyota | Model | Vios |
| YOM | 2024 | Mileage | 10,151 |

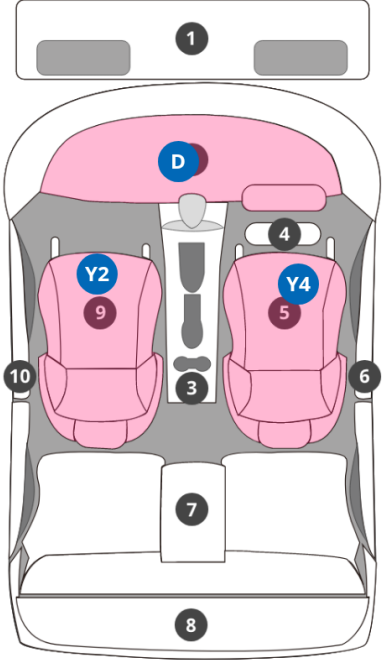
| Interior Evaluation : <b>C</b> | Exterior Evaluation : <b>E</b> |
| <p><b>Remarks</b><br/>(R) Front Seat - Grime - Large / Dashboard - Traces of Adhesive Tape - Yes / (L) Front Seat - Grime - Small</p> | <p><b>Remarks</b><br/>Front Bumper, Grille, Lamps - Crack, Gap - Large / (L) Front Door, Molding - Scratch &amp; Dent - Large / (L) Rear Door, Molding - Scratch &amp; Dent - Large / (L) Step, In-panel, Side Spoiler - Scratch &amp; Dent - Large / Rear Bumper, Lamps, Panels - Scratch - Large / (R) Rear Fender, Molding - Scratch - Medium / (R) Rear Door, Molding - Scratch &amp; Dent - Large / (R) Front Fender, Molding - Scratch - Medium / (R) Front Door, Molding - Scratch - Small / (R) Mirror - Scratch - Small</p> |
