## General Information

| Make | Mitsubishi | Model | L300 |
| Registration No. | NKT5152 | Chassis No. | PAEL65NYTSB007734 |

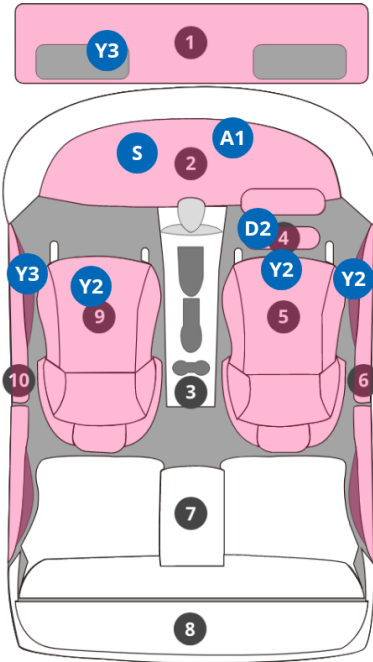
| Interior Evaluation : <span style="color: red;">B</span> | | Exterior Evaluation : <span style="color: red;">C</span> | |
|---|--|---|--|
| <p><b>Remarks</b></p> <p>Overall Interior - Smell - Yes / (L) Front Floor Mat - Worked - Small / (L) Front Seat - Grime - Small / (R) Front Seat - Grime - Small / (L) Front Trim - Grime - Medium / (R) Front Trim - Grime - Small / Sunvisor, Sunglass Holder - Grime - Medium / Dashboard - Worn, Scratch, Cut, Crack - Minimal</p> | | <p><b>Remarks</b></p> <p>(R) Front Fender, Molding - Scratch - Small / (R) Front Door, Molding - Scratch - Medium / (R) Side Gate - Scratch - Large / Rear Gate - Scratch - Minimal / Cargo Bed Floor - Scratch - Minimal / (L) Side Gate - Scratch - Medium / (L) Center Panel - Scratch - Small / (L) Front Door, Molding - Scratch - Minimal / Roof - Scratch - Minimal / Front Bumper, Grille, Lamps - Scratch &amp; Dent - Medium / Front Panel - Scratch - Minimal / (L) Front Fender, Molding - Scratch - Minimal</p> | |

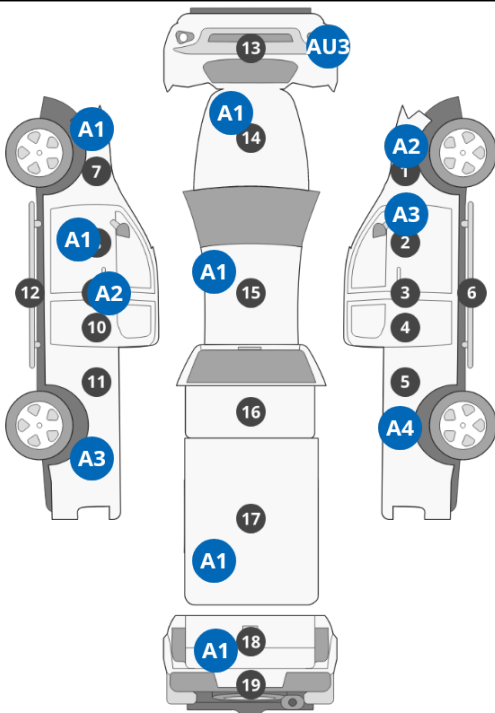
with Ito plate/with warranty booklet/with spare tire/with hairlines scratches on the body/with spare key/without tools and jack/without reverse camera
