## General Information

| Make | Toyota | Model | Innova |
| YOM | 2005 | Odo Meter Reading | 75,931 |
| Registration No. | XTR813 | Chassis No. | KUN405000067 |

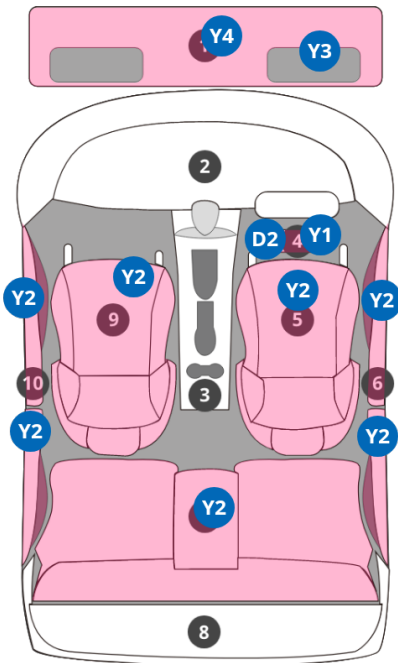
| Interior Evaluation : <b>C</b> | Exterior Evaluation : <b>E</b> |
| <p><b>Remarks</b></p> <p>(L) Front Seat - Grime - Small / (R) Front Seat - Grime - Small / Rear Seat - Grime - Small / Ceiling - Grime - Large / (R) Rear Trim - Grime - Small / (L) Rear Trim - Grime - Small / (R) Front Trim - Grime - Small / (R) Front Floor Mat - Grime - Minimal / (L) Front Trim - Grime - Small / (L) Front Floor Mat - Worked - Small / Sunvisor, Sunglass Holder - Grime - Medium / Overall Interior - Worn as per age - Yes</p> | <p><b>Remarks</b></p> <p>(L) Front Fender - Repair Traces - Yes / Trunk Hood, Rear Gate - Repair Traces - Yes / Roof - Repair Traces - Yes / (L) Front Fender, Molding - Repair mark - Yes / Trunk Hood, Rear Gate - Repair mark - Yes / Overall Exterior - Faded(Color, Gloss) - Yes / (L) Front Fender, Molding - Crack, Gap - Small / (L) Step, In-panel, Side Spoiler - Scratch - Small / (L) Front Door, Molding - Scratch &amp; Dent - Small / (L) Rear Door, Molding - Scratch - Small / (L) Rear Fender, Molding - Scratch - Small / Trunk Hood, Rear Gate - Scratch &amp; Dent - Small / Rear Bumper, Lamps, Panels - Scratch - Medium / (R) Rear Fender, Molding - Scratch &amp; Dent - Small / (R) Step, In-panel, Side Spoiler - Scratch - Small / (R) Rear Door, Molding - Scratch - Small / (R) Front Door, Molding - Scratch - Small / (R) Mirror - Scratch - Minimal / (R) Front Fender, Molding - Crack, Gap - Medium / Bonnet, Headlight - Scratch - Small / Front Bumper, Grille, Lamps - Scratch - Large / Roof - Scratch - Small</p> |

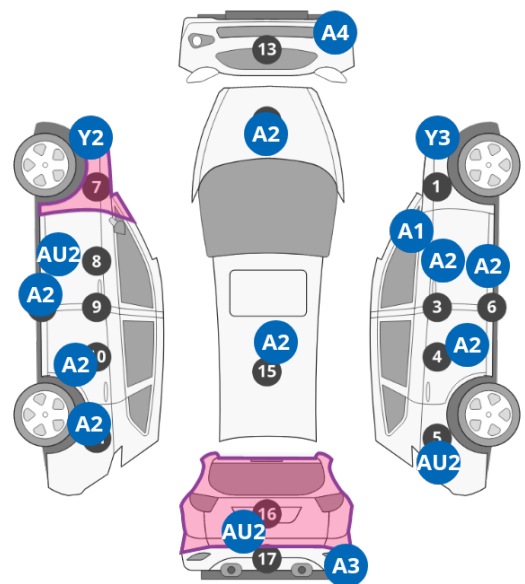
| Inspector Notes |
|---|
| <p>with LTO plate/with warranty booklet/with tools and jack/with spare tire/no fog lights/park light issue/seat belt issue/plate light issue/scratches on taillight and headlight cover/faded color/hairline scratches on the body/stereo volume switch issue/with spare key/with seat cover</p> |
