## General Information

| Make | Mitsubishi | Model | ASX |
| YOM | 2015 | Odo Meter Reading | 114,900 |

## Body / Panel Condition

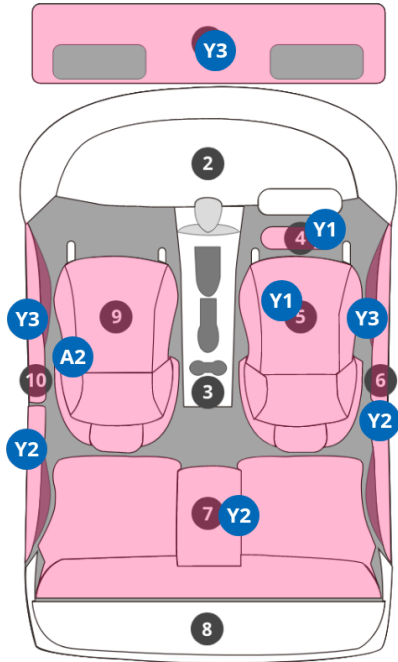
| Interior Evaluation : <span style="color: red;">C</span> | Exterior Evaluation : <span style="color: red;">D</span> |
|---|---|
| <b>Remarks</b><br>Rear Seat - Grime - Small / (R) Front Trim - Grime - Medium / (R) Front Floor Mat - Grime - Minimal / Ceiling - Grime - Medium / (R) Rear Trim - Grime - Small / (L) Rear Trim - Grime - Small / (L) Front Trim - Grime - Medium / (L) Front Seat - Cut, Crack - Small / (R) Front Seat - Grime - Minimal / Overall Interior - Worn as per age - Yes | <b>Remarks</b><br>(L) Front Fender, Molding - Scratch - Small / (L) Step, In-panel, Side Spoiler - Scratch - Small / (L) Front Door, Molding - Scratch - Small / (L) Rear Door, Molding - Scratch & Dent - Small / (L) Rear Fender, Molding - Scratch & Dent - Small / Rear Bumper, Lamps, Panels - Repair mark - Yes / Rear Bumper, Lamps, Panels - Scratch - Medium / Trunk Hood, Rear Gate - Scratch & Dent - Medium / (R) Rear Fender, Molding - Scratch - Minimal / (R) Step, In-panel, Side Spoiler - Scratch - Small / (R) Rear Door, Molding - Scratch - Small / (R) Front Door, Molding - Scratch & Dent - Small / (R) Mirror - Scratch - Small / (R) Front Fender, Molding - Scratch - Small / Front Bumper, Grille, Lamps - Scratch - Small / Bonnet, Headlight - Scratch & Dent - Minimal / Roof - Scratch - Minimal / Overall Exterior - Worn as per age - Yes |
