## General Information

| Make | Toyota | Model | Corolla |
| YOM | 2004 | Odo Meter Reading | 219,257 |
| Registration No. | XMT209 | Chassis No. | ZZE1218010878 |

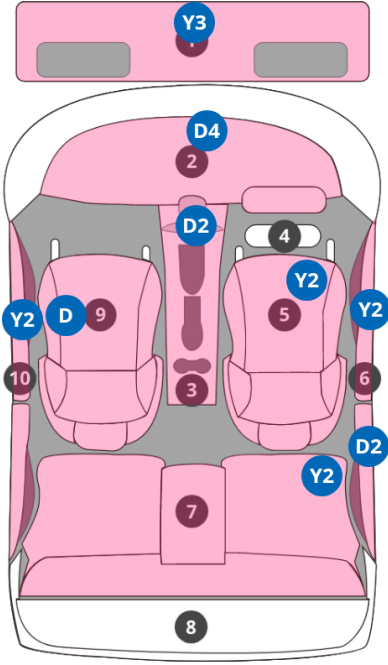
| Interior Evaluation : <span style="color: red;">C</span> | Exterior Evaluation : <span style="color: red;">E</span> |
| <b>Remarks</b><br>Overall Interior - Worn as per age - Yes / Ceiling - Grime - Medium / (R) Rear Trim - Worked - Small / (L) Front Trim - Grime - Small / (R) Front Trim - Grime - Small / (L) Front Seat - Worn - Yes / (R) Front Seat - Grime - Small / Console, Switchs, Vents - Loose, Deformed - Small / Rear Seat - Grime - Small / Dashboard - Loose, Deformed - Large | <b>Remarks</b><br>(L) Front Fender - Repair Traces - Yes / Overall Exterior - Worn as per age - Yes / Overall Exterior - Faded(Color, Gloss) - Yes / (R) Mirror - Scratch - Small / (R) Front Fender, Molding - Scratch - Minimal / (R) Front Door, Molding - Scratch & Dent - Small / (R) Step, In-panel, Side Spoiler - Scratch - Small / (R) Rear Door, Molding - Scratch & Dent - Medium / (R) Rear Fender, Molding - Scratch - Medium / Rear Bumper, Lamps, Panels - Crack, Gap - Medium / Trunk Hood, Rear Gate - Scratch - Small / (L) Front Door, Molding - Scratch - Large / (L) Rear Door, Molding - Scratch - Large / (L) Rear Fender, Molding - Scratch - Small / (L) Mirror - Faded(Color, Gloss) - Yes / (R) Mirror - Faded(Color, Gloss) - Yes / (L) Mirror - Scratch - Small / (L) Front Fender, Molding - Scratch - Small / Front Bumper, Grille, Lamps - Repair mark - Yes / Front Bumper, Grille, Lamps - Scratch - Medium / Bonnet, Headlight - Scratch - Minimal / Roof - Scratch - Small |
