## General Information

| Make | Toyota | Model | Vios |

## Overall Evaluation :

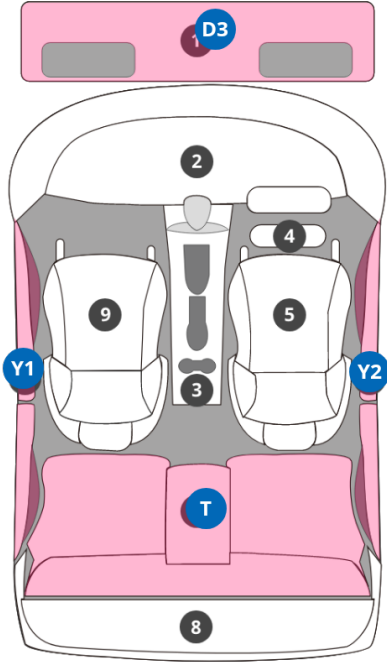
| Interior Evaluation : <b>C</b> | Exterior Evaluation : <b>E</b> |
|---|---|
| <p><b>Remarks</b><br/>Ceiling - Crinkle - Medium / (R) Front Trim - Grime - Small / (L) Front Trim - Grime - Minimal / Rear Seat - Cigarette Burns - Burnt, Hole</p> | <p><b>Remarks</b><br/>(R) Front Fender, Molding - Scratch - Medium / (R) Front Door, Molding - Scratch - Medium / (R) Step, In-panel, Side Spoiler - Scratch - Small / (R) Rear Door, Molding - Scratch &amp; Dent - Large / (R) Rear Fender, Molding - Crack, Gap - Large / (L) Front Fender, Molding - Scratch - Small / (L) Front Door, Molding - Scratch - Medium / (L) Step, In-panel, Side Spoiler - Scratch - Small / (L) Rear Door, Molding - Scratch - Medium / (L) Rear Fender, Molding - Crack, Gap - Large / Front Bumper, Grille, Lamps - Scratch - Medium / Bonnet, Headlight - Scratch - Small / Trunk Hood, Rear Gate - Dent - Large / Rear Bumper, Lamps, Panels - Crack, Gap - Large</p> |

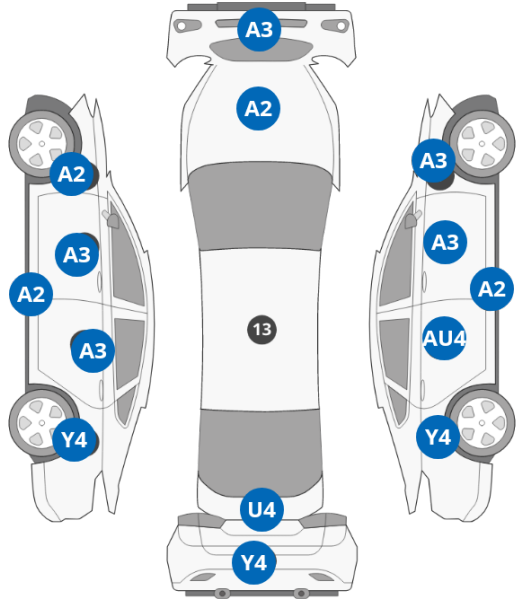
With LTO plate, with warranty booklet, with tools, with jack, with seat cover (front seats only), with hairline scratches, damaged rear bumper, cracked rear lights.
