## General Information

| Make | Toyota | Model | Vios |
| YOM | 2021 | Mileage | 79,640 |

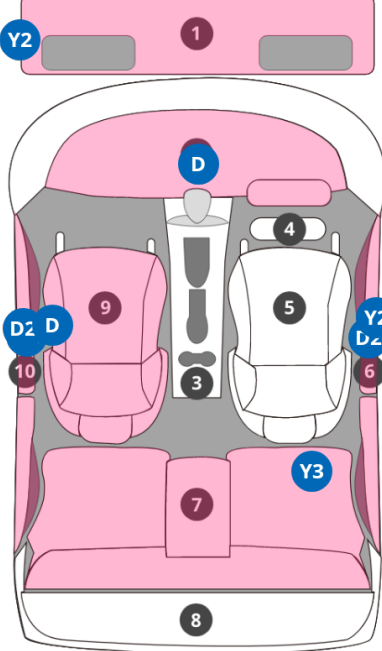
| <b>Interior Evaluation :</b> <span style="color: red; font-weight: bold;">C</span> | <b>Exterior Evaluation :</b> <span style="color: red; font-weight: bold;">D</span> |
| <b>Remarks</b><br>Rear Seat - Grime - Medium / (R) Front Trim - Worked - Small / Dashboard - Traces of Adhesive Tape - Yes / (L) Front Trim - Grime - Small / (L) Front Trim - Worked - Small / (R) Front Trim - Grime - Small / Ceiling - Grime - Small / (L) Front Seat - Worn - Yes | <b>Remarks</b><br>(R) Front Door - Repair Traces - Yes / (R) Front Fender - Repair Traces - Yes / Bonnet - Repair Traces - Yes / (L) Front Fender - Repair Traces - Yes / (L) Front Door - Repair Traces - Yes / Roof - Repair Traces - Yes / (R) Mirror - Scratch - Minimal / (R) Step, In-panel, Side Spoiler - Scratch & Dent - Medium / (R) Rear Door, Molding - Scratch - Small / Rear Bumper, Lamps, Panels - Repair mark - Yes / Rear Bumper, Lamps, Panels - Dent - Large / Trunk Hood, Rear Gate - Dent - Small / (L) Rear Fender, Molding - Scratch & Dent - Medium / (L) Rear Door, Molding - Scratch - Small / (L) Front Door, Molding - Repair mark - Yes / (L) Step, In-panel, Side Spoiler - Scratch & Dent - Small / (L) Mirror - Scratch - Minimal / Front Bumper, Grille, Lamps - Repair mark - Yes / Front Bumper, Grille, Lamps - Scratch - Small / Roof - Dent - Small / Bonnet, Headlight - Scratch - Minimal |
