## General Information

| Make | Toyota | Model | Hiace |

## Body / Panel Condition

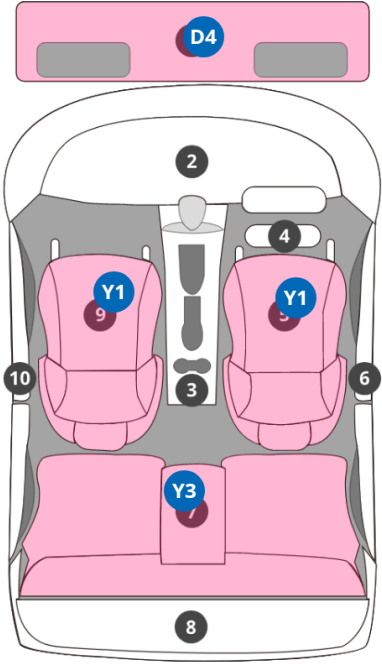
| Interior Evaluation : <b>C</b> | Exterior Evaluation : <b>D</b> |
| <b>Remarks</b><br>(R) Front Seat - Grime - Minimal / (L) Front Seat - Grime - Minimal / Rear Seat - Grime - Medium / Ceiling - Crinkle - Large | <b>Remarks</b><br>(R) Front Fender, Molding - Scratch - Minimal / (R) Front Door, Molding - Scratch - Medium / (R) Rear Door, Molding - Scratch - Medium / (R) Rear Fender, Molding - Scratch - Small / (R) Step, In-panel, Side Spoiler - Scratch - Minimal / (L) Front Fender, Molding - Scratch - Small / (L) Front Door, Molding - Scratch - Small / (L) Rear Door, Molding - Scratch - Small / (L) Step, In-panel, Side Spoiler - Scratch - Small / (L) Rear Fender, Molding - Scratch - Minimal / Front Bumper, Grille, Lamps - Scratch - Medium / Bonnet, Headlight - Scratch - Small / Trunk Hood, Rear Gate - Scratch - Minimal / Rear Bumper, Lamps, Panels - Scratch - Medium |

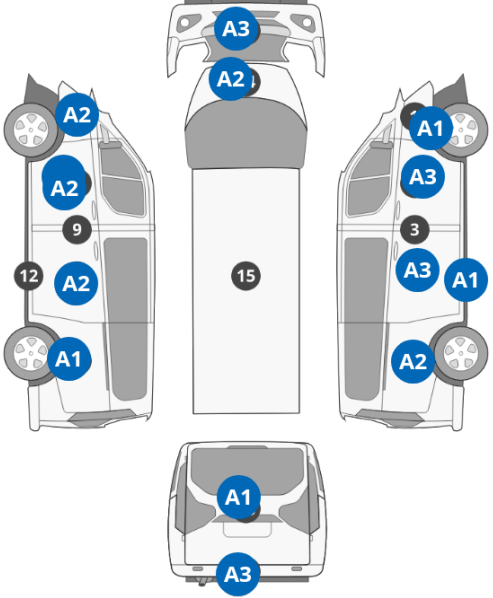
With LTO plate, with warranty booklet, with tools, with jack, no seat cover, with spare key 2pcs, with spare tire, with hairline scratches, horn not functioning.
