## General Information

| Make | Toyota | Model | Hiace |
| Registration No. | NAQ1558 | Chassis No. | JTFJT02P0J5016152 |

## Overall Evaluation :

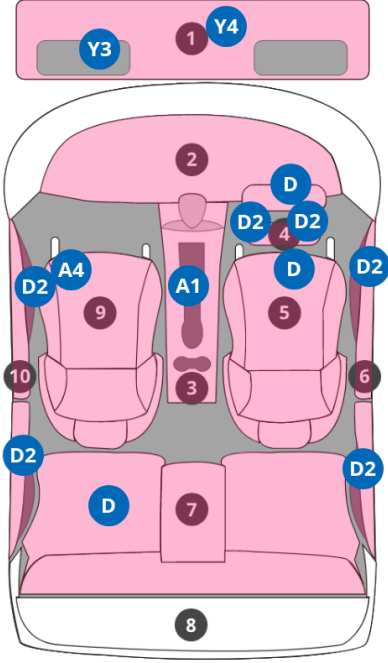
| Interior Evaluation : <b>E</b> | Exterior Evaluation : <b>E</b> |
| <b>Remarks</b><br>(L) Front Seat - Cut, Crack - Large / Dashboard - Traces of Adhesive Tape - Yes / (L) Front Floor Mat - Worked - Small / (L) Front Trim - Worked - Small / (R) Front Seat - Worn - Yes / Rear Seat - Worn - Yes / Ceiling - Grime - Large / Mat Other - Worked - Small / (R) Front Trim - Worked - Small / Overall Interior - Worn as per age - Yes / Console, Switches, Vents - Worn, Scratch, Cut, Crack - Minimal / (R) Rear Trim - Worked - Small / (L) Rear Trim - Worked - Small / Sunvisor, Sunglass Holder - Grime - Medium | <b>Remarks</b><br>(R) Front Fender, Molding - Scratch - Minimal / (R) Front Door, Molding - Scratch & Dent - Medium / (R) Center Panel - Scratch - Minimal / (R) Rear Door, Molding - Repair mark - Difference in Color / (R) Rear Door, Molding - Scratch - Large / (R) Rear Fender, Molding - Repair mark - Difference in Color / (R) Rear Fender, Molding - Scratch - Small / Trunk Hood, Rear Gate - Dent - Medium / Rear Bumper, Lamps, Panels - Scratch & Dent - Small / (L) Rear Fender, Molding - Scratch & Dent - Medium / (L) Front Door, Molding - Scratch & Dent - Medium / Front Panel - Scratch & Dent - Small / Front Bumper, Grille, Lamps - Scratch & Dent - Small / Roof - Dent - Small / Overall Exterior - Worn as per age - Yes / (L) Front Fender, Molding - Scratch - Minimal / (L) Step, In-panel, Side Spoiler - Scratch - Small / (R) Step, In-panel, Side Spoiler - Scratch - Small |

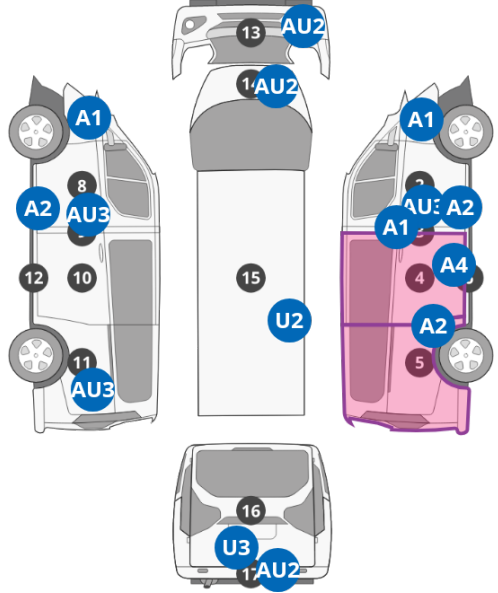
| Inspector Notes |
|---|
| with Ito plate/with warranty booklet/with jack no tools/with spare tire/with dent and hairlines scratches on the body/without spare key/engine unusual noise/without reverse camera/worn tires/reverse light issue |
