## General Information

| Make | Toyota | Model | Vios |

## Body / Panel Condition

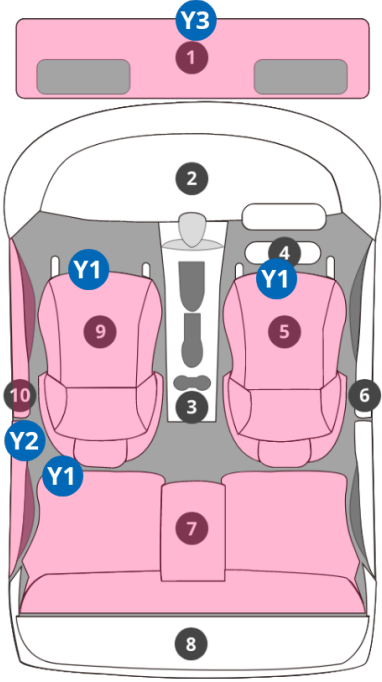
| Interior Evaluation : <b>B</b> | Exterior Evaluation : <b>C</b> |
| <p><b>Remarks</b></p> <p>Rear Seat - Grime - Minimal / (L) Front Seat - Grime - Minimal / (R) Front Seat - Grime - Minimal / Ceiling - Grime - Medium / (L) Rear Trim - Grime - Small</p> | <p><b>Remarks</b></p> <p>(R) Front Door - Repair Traces - Yes / (R) Front Fender - Repair Traces - Yes / Bonnet - Repair Traces - Yes / (L) Front Fender - Repair Traces - Yes / (L) Front Door - Repair Traces - Yes / (L) Rear Door - Repair Traces - Yes / (L) Rear Fender - Repair Traces - Yes / Trunk Hood, Rear Gate - Repair Traces - Yes / (R) Rear Fender - Repair Traces - Yes / (R) Rear Door - Repair Traces - Yes / Roof - Repair Traces - Yes / (R) Front Door, Molding - Scratch - Small / (R) Rear Door, Molding - Scratch - Small / (R) Rear Fender, Molding - Scratch - Small / Rear Bumper, Lamps, Panels - Dent - Minimal / (L) Front Fender, Molding - Crack, Gap - Medium / Front Bumper, Grille, Lamps - Scratch &amp; Dent - Large / Front Bumper, Grille, Lamps - Repair mark - Yes / (L) Front Door, Molding - Repair mark - Yes / (R) Rear Wheel, Cover - Scratch, Corrosion - Small / (R) Front Fender, Molding - Scratch &amp; Dent - Small</p> |
