## General Information

| Make | Toyota | Model | Vios |
| YOM | 2021 | Mileage | 47,968 |

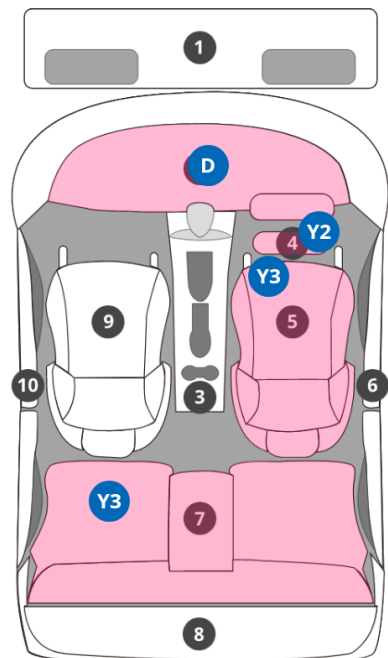
| <div>Interior Evaluation : <span>B</span></div> | <div>Exterior Evaluation : <span>E</span></div> |
| <div> <div>Remarks</div> <div>(R) Front Seat - Grime - Medium / (R) Front Floor Mat - Grime - Small / Rear Seat - Grime - Medium / Dashboard - Traces of Adhesive Tape - Yes</div> </div> | <div> <div>Remarks</div> <div>(L) Front Door, Molding - Scratch &amp; Dent - Large / (L) Rear Door, Molding - Scratch &amp; Dent - Medium / Member (Bolted) - Dent - Yes / Front Bumper, Grille, Lamps - Scratch &amp; Dent - Large / (R) Mirror - Scratch - Small / (R) Rear Door, Molding - Scratch &amp; Dent - Medium / (R) Rear Fender, Molding - Scratch &amp; Dent - Small / Rear Bumper, Lamps, Panels - Scratch &amp; Dent - Large / (L) Rear Fender, Molding - Scratch - Small / (L) Front Fender, Molding - Scratch - Medium / (L) Mirror - Scratch - Small / Roof - Scratch - Minimal</div> </div> |

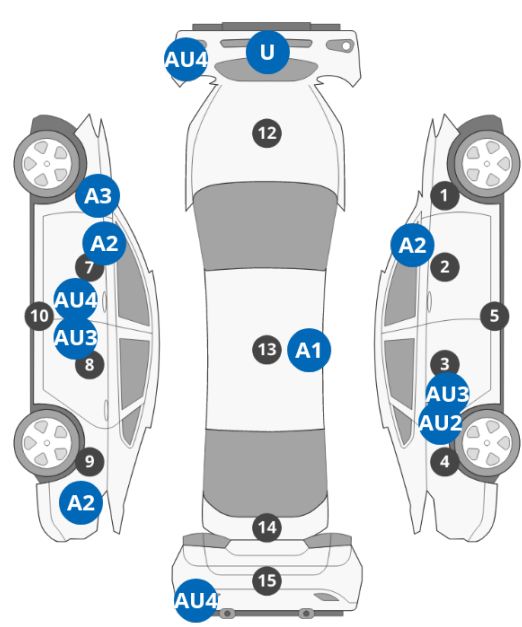
crack left taillight. Large Gap at front bumper and right front fender. with warranty booklet, spare tire, jack but incomplete tools. with LTO plate.
