## General Information

| Make | Toyota | Model | Avanza |

## Body / Panel Condition

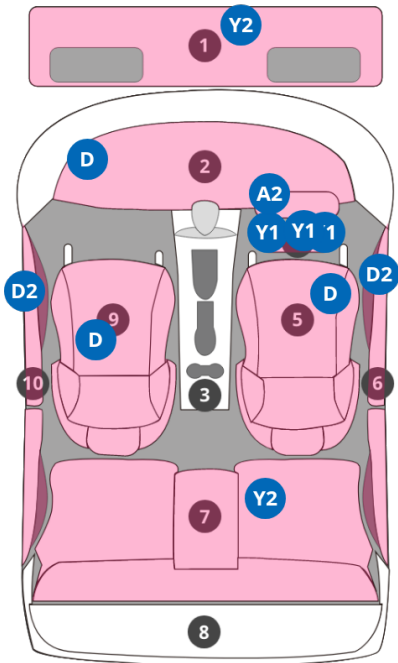
| Interior Evaluation : <span style="color: red;">C</span> | Exterior Evaluation : <span style="color: red;">E</span> |
|---|---|
| <b>Remarks</b><br>(L) Front Seat - Worn - Yes / (R) Front Seat - Worn - Yes / (L) Front Floor Mat - Grime - Minimal / (R) Front Floor Mat - Grime - Minimal / Rear Seat - Grime - Small / Mat Other - Grime - Minimal / Dashboard - Traces of Adhesive Tape - Yes / Ceiling - Grime - Small / Steering Wheel - Worn, Peel, Crack - Small / (L) Front Trim - Worked - Small / (R) Front Trim - Worked - Small | <b>Remarks</b><br>(R) Front Fender, Molding - Scratch & Dent - Small / (R) Front Door, Molding - Scratch & Dent - Medium / (R) Rear Door, Molding - Scratch - Medium / (R) Step, In-panel, Side Spoiler - Scratch & Dent - Medium / (R) Rear Fender, Molding - Scratch & Dent - Small / Rear Bumper, Lamps, Panels - Scratch - Medium / Trunk Hood, Rear Gate - Scratch - Medium / (L) Rear Fender, Molding - Scratch - Small / (L) Rear Door, Molding - Scratch - Medium / (L) Step, In-panel, Side Spoiler - Scratch - Small / (L) Front Door, Molding - Scratch & Dent - Small / (L) Front Fender, Molding - Scratch - Small / Front Bumper, Grille, Lamps - Scratch & Dent - Medium / Bonnet, Headlight - Scratch - Minimal / Roof - Scratch - Minimal |

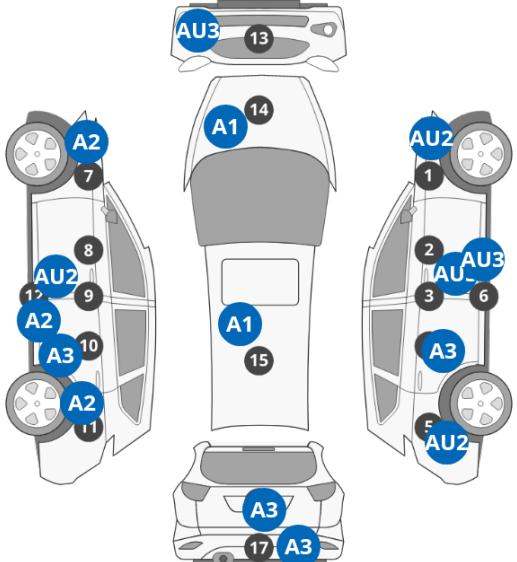
| Inspector Notes |
|---|
| with Ito plate/warranty booklet/with spare tire/with jack no tools/with reverse camera/with dashcam/with dent and hairlines scratches on the body/plate light issue/maintenance warning lamp on |
