## General Information

| Make | Toyota | Model | Avanza |
| Registration No. | NJQ3234 | Chassis No. | MHFAA1BY1S0043229 |

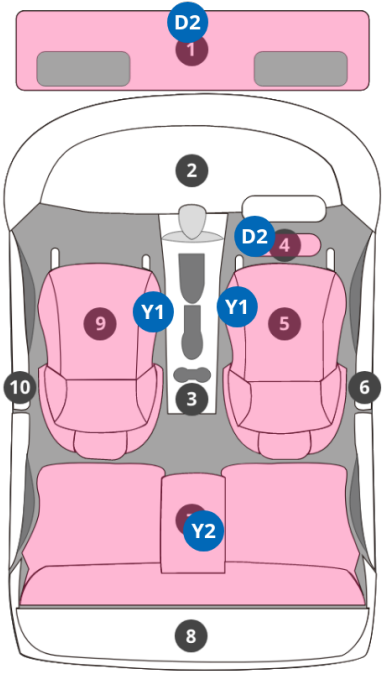
| Interior Evaluation : <span style="color: red; font-weight: bold;">A</span> | Exterior Evaluation : <span style="color: red; font-weight: bold;">D</span> |
|---|---|
| <p><b>Remarks</b><br/>(L) Front Floor Mat - Worked - Small / (L) Front Seat - Grime - Minimal / (R) Front Seat - Grime - Minimal / Rear Seat - Grime - Small / Ceiling - Crinkle - Small</p> | <p><b>Remarks</b><br/>(R) Front Fender, Molding - Scratch - Small / (R) Mirror - Scratch - Minimal / (R) Rear Door, Molding - Scratch - Large / (R) Front Door, Molding - Scratch - Medium / (R) Rear Fender, Molding - Scratch - Small / Rear Bumper, Lamps, Panels - Scratch - Small / Trunk Hood, Rear Gate - Scratch - Minimal / (L) Rear Fender, Molding - Scratch &amp; Dent - Medium / (L) Rear Door, Molding - Scratch - Small / (L) Front Door, Molding - Scratch - Small / (L) Mirror - Scratch - Small / (L) Front Fender, Molding - Scratch - Minimal / Front Bumper, Grille, Lamps - Scratch - Medium / Bonnet, Headlight - Scratch - Minimal / Roof - Scratch - Small</p> |

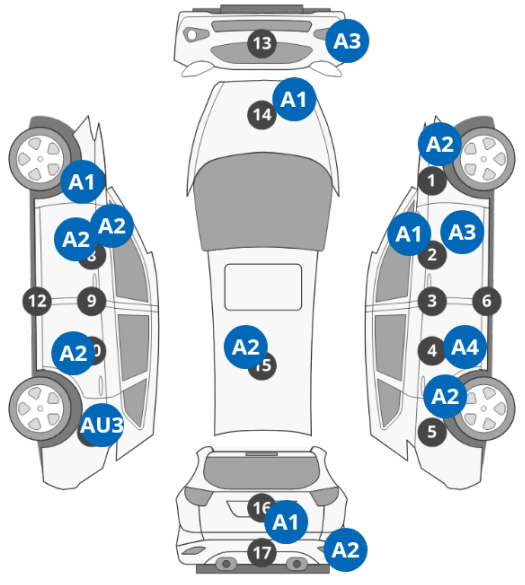
| Inspector Notes |
|---|
| with warranty booklet, jack and tools, with spare tire, with LTO plate, scratches on tail light |
