## General Information

| Make | Toyota | Model | Avanza |

## Body / Panel Condition

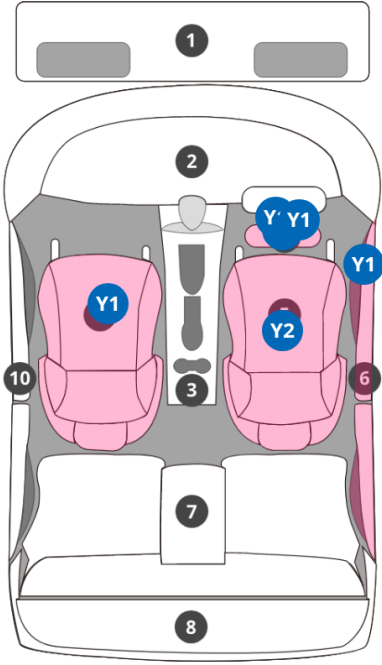
| Interior Evaluation : <span style="color: red; font-weight: bold;">A</span> | Exterior Evaluation : <span style="color: red; font-weight: bold;">E</span> |
| <b>Remarks</b><br>(R) Front Seat - Grime - Small / (R) Front Floor Mat - Grime - Minimal / (L) Front Seat - Grime - Minimal / (L) Front Floor Mat - Grime - Minimal / Mat Other - Grime - Minimal / (R) Front Trim - Grime - Minimal | <b>Remarks</b><br>(R) Front Door, Molding - Scratch & Dent - Minimal / (R) Rear Door, Molding - Scratch - Small / (R) Step, In-panel, Side Spoiler - Scratch & Dent - Medium / (R) Rear Fender, Molding - Scratch & Dent - Small / Trunk Hood, Rear Gate - Scratch & Dent - Small / Rear Bumper, Lamps, Panels - Scratch - Small / (L) Rear Fender, Molding - Scratch & Dent - Medium / (L) Rear Door, Molding - Scratch & Dent - Large / (L) Front Door, Molding - Scratch & Dent - Large / (L) Front Fender, Molding - Scratch & Dent - Small / (L) Step, In-panel, Side Spoiler - Scratch & Dent - Small / Roof - Scratch & Dent - Small / (R) Front Fender, Molding - Scratch & Dent - Minimal / Front Bumper, Grille, Lamps - Scratch - Medium / Bonnet, Headlight - Scratch - Small |

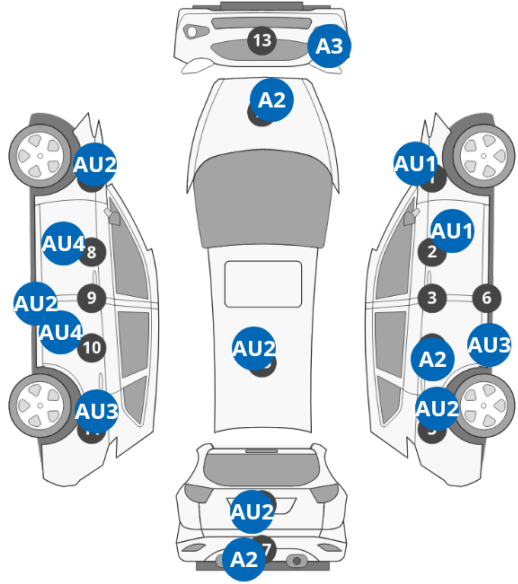
with LTO plate, with spare tire and key, with jack and inc tools, with reverse camera, no warranty and manual booklet, scratches and dent on exterior, scratches in taillight and headlight.
