## General Information

| Make | Toyota | Model | Avanza |
| Registration No. | DBT2435 | Chassis No. | MHFAB1BY4R3132931 |

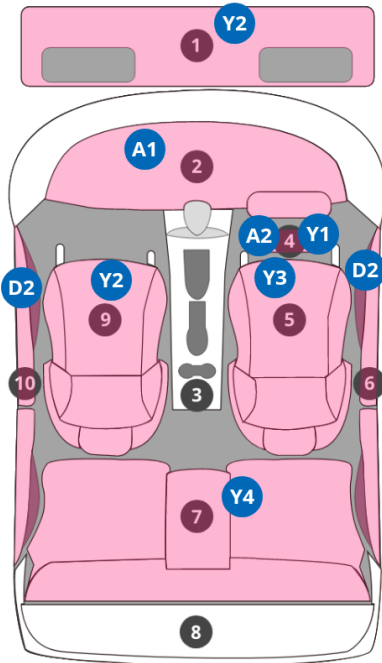
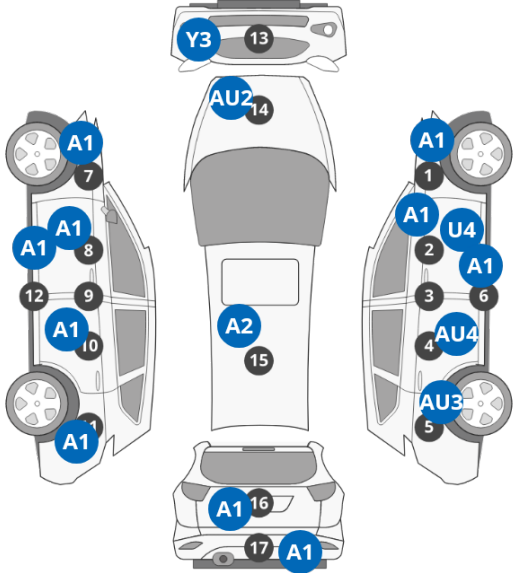
| Interior Evaluation : <b>C</b> | Exterior Evaluation : <b>D</b> |
|---|---|
| <p><b>a</b> : Cut, Fray <b>d</b> : Loose, Deformed <b>k</b> : Animal Hair <b>s</b> : Smell <b>t</b> : Cigarette Burns <b>x</b> : Defective <b>y</b> : Stain</p> | <p><b>A</b> : Scratch <b>AU</b> : Scratch &amp; Dent <b>B</b> : Modified <b>C</b> : Corrosion <b>G</b> : Stone chip <b>P</b> : Faded <b>S</b> : Rust <b>SC</b> : Rust &amp; Corrosion <b>U</b> : Dent <b>X</b> : Defective <b>Y</b> : Crack, Gap</p> |
| <p><b>Remarks</b></p> <p>(L) Front Seat - Grime - Small / (R) Front Seat - Grime - Medium / Rear Seat - Grime - Large / Dashboard - Worn, Scratch, Cut, Crack - Minimal / (L) Front Floor Mat - Cut, Crack - Small / (R) Front Floor Mat - Grime - Minimal / (L) Front Trim - Worked - Small / (R) Front Trim - Worked - Small / Ceiling - Grime - Small</p> | <p><b>Remarks</b></p> <p>(R) Front Fender, Molding - Scratch - Minimal / (R) Mirror - Scratch - Minimal / (R) Front Door, Molding - Dent - Large / (R) Rear Door, Molding - Scratch &amp; Dent - Large / (R) Rear Fender, Molding - Scratch &amp; Dent - Medium / Rear Bumper, Lamps, Panels - Scratch - Minimal / Trunk Hood, Rear Gate - Scratch - Minimal / (L) Rear Fender, Molding - Scratch - Minimal / (L) Rear Door, Molding - Scratch - Minimal / (L) Front Door, Molding - Scratch - Minimal / (L) Step, In-panel, Side Spoiler - Scratch - Minimal / (R) Step, In-panel, Side Spoiler - Scratch - Minimal / (L) Front Fender, Molding - Scratch - Minimal / Front Bumper, Grille, Lamps - Crack, Gap - Medium / Bonnet, Headlight - Scratch &amp; Dent - Small / Roof - Scratch - Small</p> |
