## General Information

| Make | Toyota | Model | Avanza |
| Registration No. | NJA2085 | Chassis No. | MHFAB1BY4R3126210 |

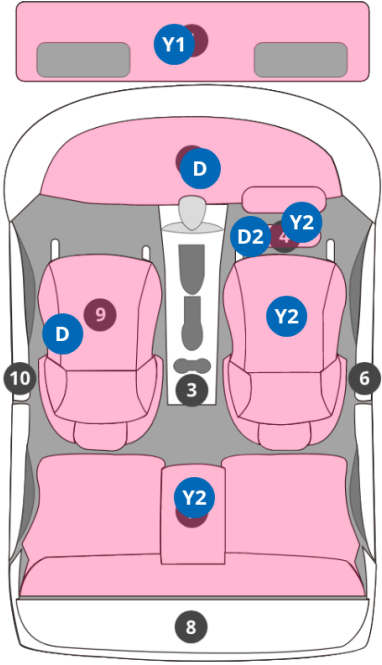
| Interior Evaluation : <b>B</b> | Exterior Evaluation : <b>E</b> |
|---|---|
| <p><b>Remarks</b><br/>Rear Seat - Grime - Small / (R) Front Floor Mat - Grime - Small / (L) Front Floor Mat - Worked - Small / (L) Front Seat - Worn - Yes / Dashboard - Traces of Adhesive Tape - Yes / Ceiling - Grime - Minimal / (R) Front Seat - Grime - Small</p> | <p><b>Remarks</b><br/>(L) Step, In-panel, Side Spoiler - Scratch &amp; Dent - Medium / (L) Rear Door, Molding - Scratch &amp; Dent - Small / (L) Front Door, Molding - Scratch - Small / (L) Front Fender, Molding - Scratch - Small / (L) Rear Fender, Molding - Scratch &amp; Dent - Small / Trunk Hood, Rear Gate - Scratch - Small / Rear Bumper, Lamps, Panels - Scratch - Medium / (R) Rear Fender, Molding - Scratch &amp; Dent - Small / (R) Rear Door, Molding - Scratch &amp; Dent - Large / (R) Step, In-panel, Side Spoiler - Scratch &amp; Dent - Medium / (R) Front Door, Molding - Scratch - Minimal / (R) Mirror - Scratch - Minimal / (R) Front Fender, Molding - Crack, Gap - Small / Front Bumper, Grille, Lamps - Scratch - Medium / Bonnet, Headlight - Scratch &amp; Dent - Large / Roof - Rust, Corrosion - Small</p> |
