## General Information

| Make | Toyota | Model | Vios |

## Body / Panel Condition

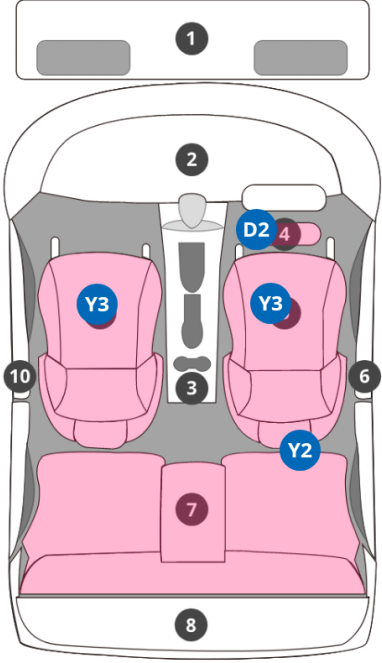
| <b>Remarks</b><br>(L) Front Seat - Grime - Medium / Rear Seat - Grime - Small / (R) Front Seat - Grime - Medium / (L) Front Floor Mat - Worked - Small | <b>Remarks</b><br>Bonnet, Headlight - Scratch - Medium / (R) Front Fender, Molding - Dent - Medium / Front Bumper, Grille, Lamps - Scratch - Medium / (L) Front Fender, Molding - Scratch - Medium / (L) Front Door, Molding - Scratch - Large / (L) Rear Door, Molding - Scratch & Dent - Small / (L) Rear Door, Molding - Repair mark - Difference in Color / (L) Rear Fender, Molding - Scratch - Small / Trunk Hood, Rear Gate - Scratch - Small / (R) Rear Fender, Molding - Scratch & Dent - Medium / (R) Rear Door, Molding - Scratch & Dent - Medium / (R) Front Door, Molding - Scratch - Large / Roof - Dent - Small |
