## General Information

| Make | Toyota | Model | Hilux Tamaraw |

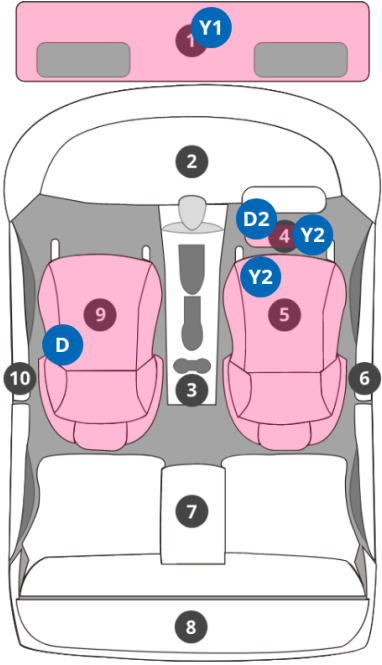
| Interior Evaluation : <b>B</b> | Exterior Evaluation : <b>C</b> |
| <p><b>Remarks</b><br/>(R) Front Seat - Grime - Small / (R) Front Floor Mat - Grime - Small / (L) Front Seat - Worn - Yes / (L) Front Floor Mat - Worn - Small / Ceiling - Grime - Minimal</p> | <p><b>Remarks</b><br/>Front Bumper, Grille, Lamps - Scratch - Small / Bonnet, Headlight - Scratch - Minimal / (R) Front Fender, Molding - Scratch - Minimal / (R) Mirror - Scratch - Minimal / (R) Front Door, Molding - Scratch - Minimal / (R) Step, In-panel, Side Spoiler - Scratch - Minimal / (R) Side Gate - Scratch &amp; Dent - Large / Rear Bumper, Lamps, Panels - Scratch - Small / Rear Gate - Scratch - Medium / Cargo Bed Floor - Scratch - Small / (L) Side Gate - Scratch - Medium / (L) Step, In-panel, Side Spoiler - Scratch - Minimal / (L) Mirror - Scratch - Minimal / (L) Front Door, Molding - Scratch - Small / (L) Front Fender, Molding - Scratch - Minimal / Roof - Scratch - Minimal</p> |
