## General Information

| Make | Mitsubishi | Model | L300 |

## Body / Panel Condition

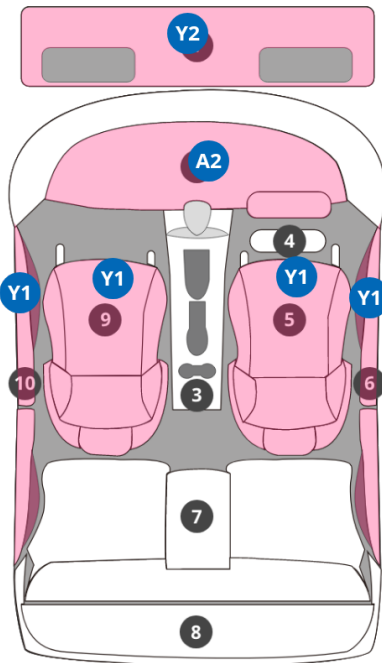
| Interior Evaluation : <span style="color: red; font-weight: bold;">A</span> | Exterior Evaluation : <span style="color: red; font-weight: bold;">C</span> |
| <b>Remarks</b><br>Ceiling - Grime - Small / (R) Front Trim - Grime - Minimal / Dashboard - Worn, Scratch, Cut, Crack - Small / (R) Front Seat - Grime - Minimal / (L) Front Trim - Grime - Minimal / (L) Front Seat - Grime - Minimal | <b>Remarks</b><br>(R) Front Fender, Molding - Scratch - Minimal / (R) Mirror - Scratch - Minimal / (R) Front Door, Molding - Scratch & Dent - Minimal / (R) Side Gate - Scratch - Medium / Rear Bumper, Lamps, Panels - Scratch - Small / Rear Gate - Scratch - Minimal / Rear Gate - Modified - Small / Cab Back Panel - Modified - Large / (L) Side Gate - Scratch & Dent - Medium / (L) Front Door, Molding - Scratch & Dent - Minimal / Front Panel - Scratch - Minimal / Front Bumper, Grille, Lamps - Crack, Gap - Medium / (L) Step, In-panel, Side Spoiler - Scratch - Minimal / (L) Mirror - Scratch - Minimal / (R) Step, In-panel, Side Spoiler - Scratch - Small |
