## General Information

| Make | Toyota | Model | Hilux Tamaraw |
| Registration No. | NJE9852 | Chassis No. | PAHACACA1S6424783 |

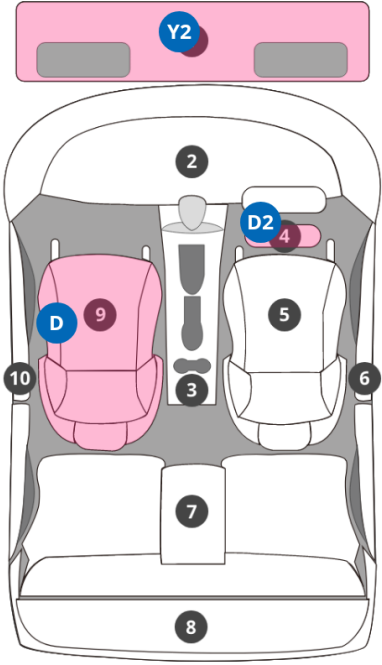
| Interior Evaluation : <b>B</b> | Exterior Evaluation : <b>E</b> |
|---|---|
| <b>Remarks</b><br>(L) Front Seat - Worn - Yes / Ceiling - Grime - Small / (L) Front Floor Mat - Worked - Small | <b>Remarks</b><br>Member (Bolted) - Dent - Yes / (R) Front Fender, Molding - Crack, Gap - Medium / (R) Mirror - Scratch - Small / (R) Center Panel - Scratch - Minimal / (R) Front Door, Molding - Scratch - Small / (R) Side Gate - Scratch & Dent - Medium / Rear Bumper, Lamps, Panels - Scratch & Dent - Medium / Rear Gate - Scratch - Small / Cargo Bed Floor - Scratch & Dent - Large / Cab Back Panel - Scratch - Small / (L) Side Gate - Scratch - Large / (L) Center Panel - Scratch - Minimal / (L) Front Door, Molding - Scratch - Small / (L) Mirror - Scratch - Small / (L) Front Fender, Molding - Crack, Gap - Medium / Front Bumper, Grille, Lamps - Crack, Gap - Large / Bonnet, Headlight - Crack, Gap - Large / Roof - Scratch - Small |

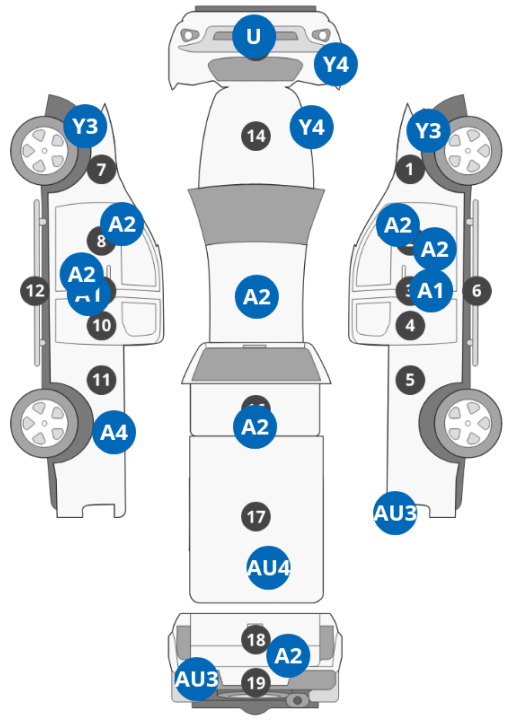
| Inspector Notes |
|---|
| no warranty booklet, with jack and tools, with spare tire, with LTO plate, scratches on headlight and tail light, cracked tail light, check engine warning lamp ON, malfunction indicator light ON, engine hood latch issue |
