## General Information

| Make | Toyota | Model | Hilux Tamaraw |

## Body / Panel Condition

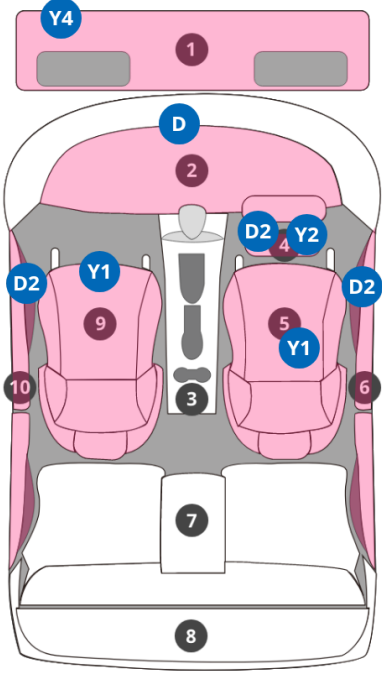
| Interior Evaluation : <b>C</b> | Exterior Evaluation : <b>D</b> |
| <b>Remarks</b><br>Dashboard - Traces of Adhesive Tape - Yes / Ceiling - Grime - Large / (L) Front Floor Mat - Worked - Small / (R) Front Floor Mat - Grime - Small / (L) Front Seat - Grime - Minimal / (R) Front Seat - Grime - Minimal / (R) Front Trim - Worked - Small / (L) Front Trim - Worked - Small | <b>Remarks</b><br>(R) Front Fender, Molding - Scratch - Minimal / (R) Front Door, Molding - Scratch - Small / (R) Step, In-panel, Side Spoiler - Scratch - Minimal / (R) Side Gate - Scratch & Dent - Large / Cargo Bed Floor - Scratch - Large / Rear Gate - Scratch & Dent - Minimal / (L) Side Gate - Scratch - Medium / (L) Front Door, Molding - Scratch - Small / (L) Step, In-panel, Side Spoiler - Scratch - Minimal / Roof - Dent - Small / (L) Front Fender, Molding - Scratch - Medium / Front Bumper, Grille, Lamps - Scratch & Dent - Large / Bonnet, Headlight - Scratch - Minimal |

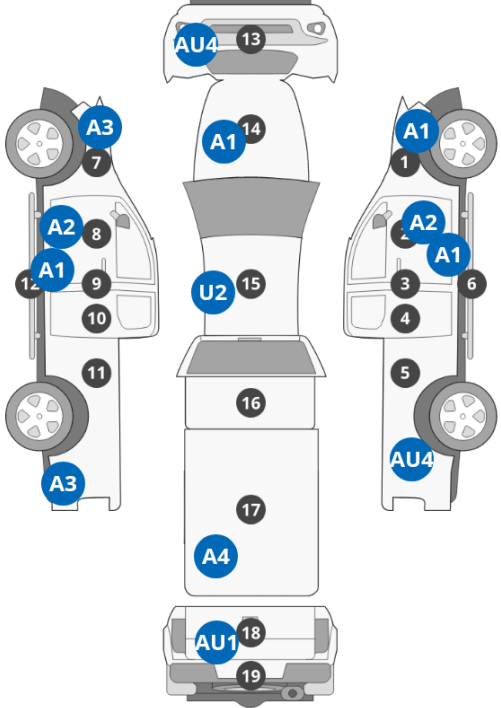
with Ito plate/with spare tire/without warranty booklet/with spare key/with dent and hairlines scratches on the body/without reverse camera/with tools and jack/with rear tail light damage
