## General Information

| Make | Toyota | Model | Hilux Tamaraw |
| Registration No. | NKU6849 | Chassis No. | PAHACACA0S6427531 |

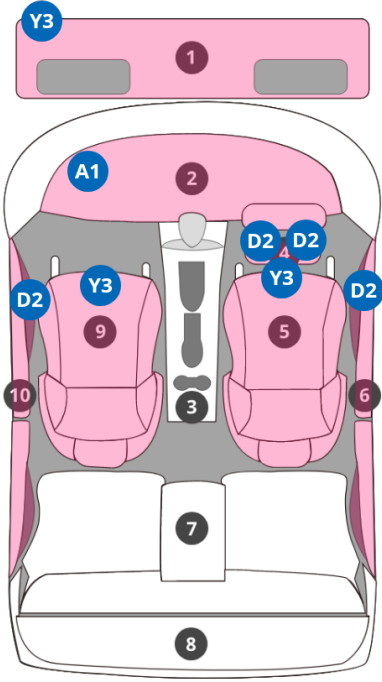
| Interior Evaluation : <b>C</b> | Exterior Evaluation : <b>D</b> |
| <b>Remarks</b><br>Ceiling - Grime - Medium / (R) Front Seat - Grime - Medium / (L) Front Seat - Grime - Medium / (L) Front Floor Mat - Worked - Small / (R) Front Floor Mat - Worked - Small / Dashboard - Worn, Scratch, Cut, Crack - Minimal / (L) Front Trim - Worked - Small / (R) Front Trim - Worked - Small | <b>Remarks</b><br>(R) Front Fender, Molding - Scratch - Minimal / (R) Mirror - Scratch - Minimal / (R) Front Door, Molding - Scratch - Minimal / (R) Step, In-panel, Side Spoiler - Scratch - Minimal / (R) Side Gate - Scratch - Medium / Rear Gate - Scratch & Dent - Medium / Cargo Bed Floor - Scratch - Large / (L) Side Gate - Scratch - Small / (L) Step, In-panel, Side Spoiler - Scratch - Small / (L) Front Door, Molding - Scratch & Dent - Medium / (L) Front Fender, Molding - Scratch - Minimal / Bonnet, Headlight - Scratch - Minimal / Front Bumper, Grille, Lamps - Scratch - Medium / Roof - Scratch - Small |

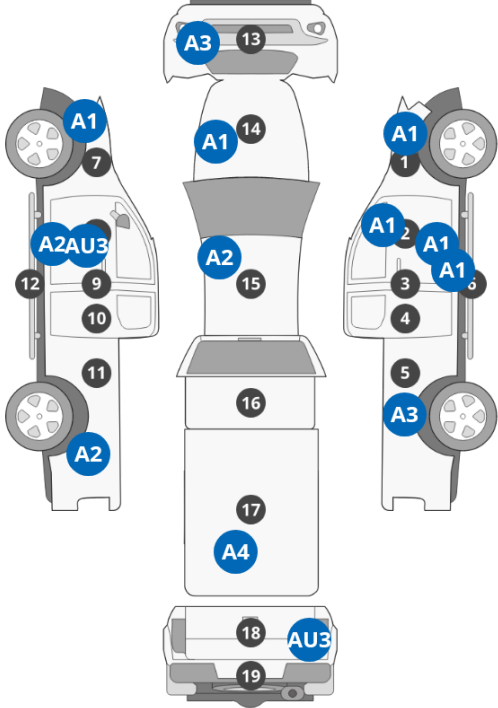
| Inspector Notes |
|---|
| with Ito plate/with warranty booklet/with spare tire/with dent and hairlines scratches on the body/without spare key/without tools and jack/without reverse camera/with rear tail light damage |
