## General Information

| Make | Toyota | Model | Vios |

## Body / Panel Condition

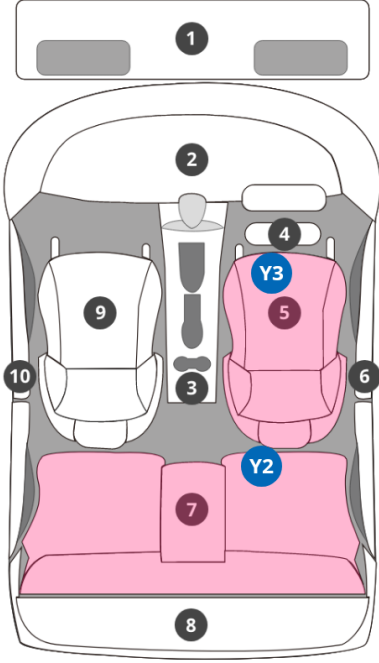
| Interior Evaluation : <b>B</b> | Exterior Evaluation : <b>B</b> |
|---|---|
| <b>Remarks</b><br>(R) Front Seat - Grime - Medium / Rear Seat - Grime - Small | <b>Remarks</b><br>(L) Mirror - Scratch - Small / (R) Rear Door, Molding - Dent - Small / (R) Front Fender, Molding - Dent - Medium / Front Bumper, Grille, Lamps - Scratch - Small / Rear Bumper, Lamps, Panels - Scratch - Minimal |
