## General Information

| Make | Toyota | Model | Hilux Tamaraw |

## Body / Panel Condition

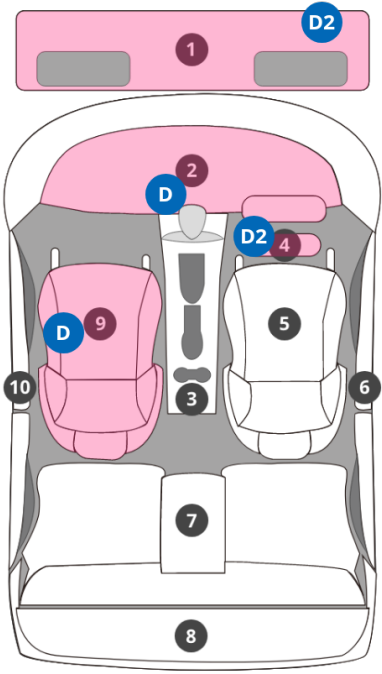
| Interior Evaluation : <b>B</b> | Exterior Evaluation : <b>E</b> |
| <p><b>Remarks</b><br/>(L) Front Floor Mat - Worked - Small / (L) Front Seat - Worn - Yes / Dashboard - Traces of Adhesive Tape - Yes / Ceiling - Crinkle - Small</p> | <p><b>Remarks</b><br/>(R) Side Window - Damaged - Large / (R) Front Fender, Molding - Scratch - Small / (R) Mirror - Scratch - Small / (R) Front Door, Molding - Scratch - Small / (R) Side Gate - Scratch &amp; Dent - Large / Rear Gate - Scratch - Medium / Rear Bumper, Lamps, Panels - Scratch - Medium / Cargo Bed Floor - Scratch &amp; Dent - Large / Cab Back Panel - Scratch &amp; Dent - Large / (L) Side Gate - Scratch &amp; Dent - Large / (L) Front Door, Molding - Scratch &amp; Dent - Medium / (L) Center Panel - Scratch - Minimal / (L) Mirror - Scratch - Small / (L) Front Fender, Molding - Scratch - Small / Front Bumper, Grille, Lamps - Scratch - Small / Bonnet, Headlight - Scratch - Minimal / Roof - Scratch - Minimal</p> |

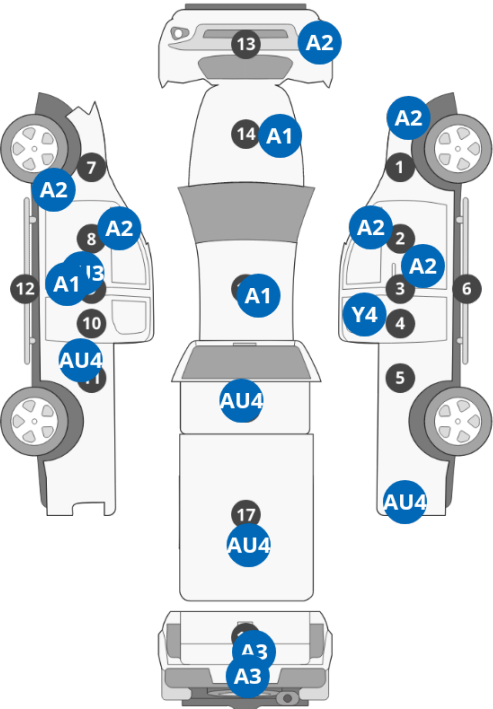
no warranty booklet, with jack and tools, with spare tire, with LTO plate, scratches on tail light, cab side window issue, cab ceiling head lining issue, abnormal noise when closing rear door
