## General Information

| Make | Toyota | Model | Hilux Tamaraw |
| Registration No. | NLC6160 | Chassis No. | PAHACACA8S6431973 |

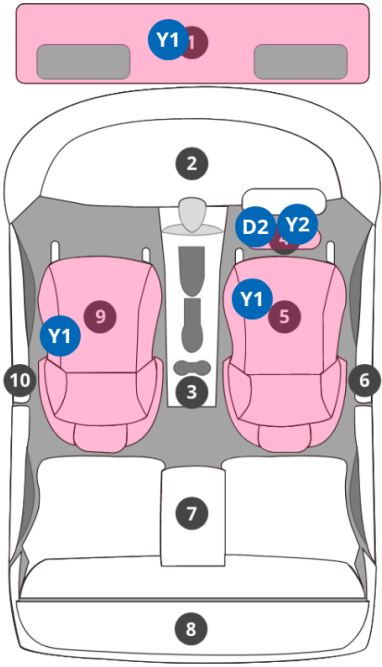
| Interior Evaluation : <span style="color: red; font-weight: bold;">A</span> | Exterior Evaluation : <span style="color: red; font-weight: bold;">D</span> |
|---|---|
| <b>Remarks</b><br>(R) Front Seat - Grime - Minimal / (R) Front Floor Mat - Grime - Small / (L) Front Floor Mat - Worked - Small / (L) Front Seat - Grime - Minimal / Ceiling - Grime - Minimal | <b>Remarks</b><br>Cargo Bed Floor - Scratch - Large / Rear Bumper, Lamps, Panels - Scratch - Small / Rear Gate - Scratch - Minimal / (L) Side Gate - Scratch & Dent - Small / (R) Side Gate - Scratch - Medium / (R) Front Door, Molding - Scratch - Large / (R) Center Panel - Scratch - Small / (R) Step, In-panel, Side Spoiler - Scratch - Minimal / (R) Front Fender, Molding - Scratch - Medium / (R) Mirror - Stuck - Yes / Bonnet, Headlight - Scratch - Minimal / Front Bumper, Grille, Lamps - Scratch - Large / (L) Front Fender, Molding - Scratch - Minimal / (L) Front Door, Molding - Scratch - Minimal / (L) Step, In-panel, Side Spoiler - Scratch - Minimal / Roof - Scratch - Minimal |
