## General Information

| Make | Toyota | Model | Lite Ace |
| Registration No. | NJC5222 | Chassis No. | MHKU3FE10SK011164 |

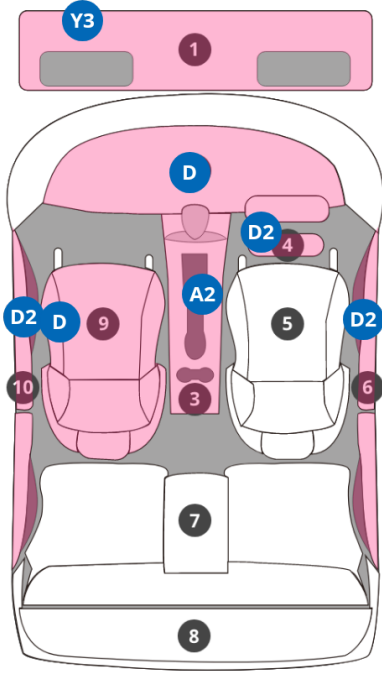
| Interior Evaluation : <b>B</b> | Exterior Evaluation : <b>E</b> |
|---|---|
| <p><b>Remarks</b></p> <p>(L) Front Floor Mat - Worked - Small / Dashboard - Traces of Adhesive Tape - Yes / Ceiling - Grime - Medium / (R) Front Trim - Worked - Small / (L) Front Trim - Worked - Small / (L) Front Seat - Worn - Yes / Knobs - Worn, Peel, Crack - Small</p> | <p><b>Remarks</b></p> <p>(R) Rear Corner Panel - Repair Traces - Yes / (R) Center Panel - Dent - Minimal / (R) Front Fender, Molding - Scratch - Minimal / (R) Mirror - Scratch - Small / (R) Front Door, Molding - Scratch - Small / (R) Side Gate - Scratch - Medium / Rear Bumper, Lamps, Panels - Crack, Gap - Medium / Cab Back Panel - Scratch - Medium / Rear Gate - Scratch &amp; Dent - Medium / (L) Side Gate - Repair mark - Yes / (L) Side Gate - Scratch &amp; Dent - Medium / (L) Front Door, Molding - Scratch - Small / (L) Mirror - Scratch - Small / (L) Step, In-panel, Side Spoiler - Scratch - Minimal / (L) Front Fender, Molding - Scratch - Minimal / Front Bumper, Grille, Lamps - Scratch - Medium / Front Panel - Scratch - Small / Roof - Dent - Medium / Member (Bolted) - Dent - Yes</p> |

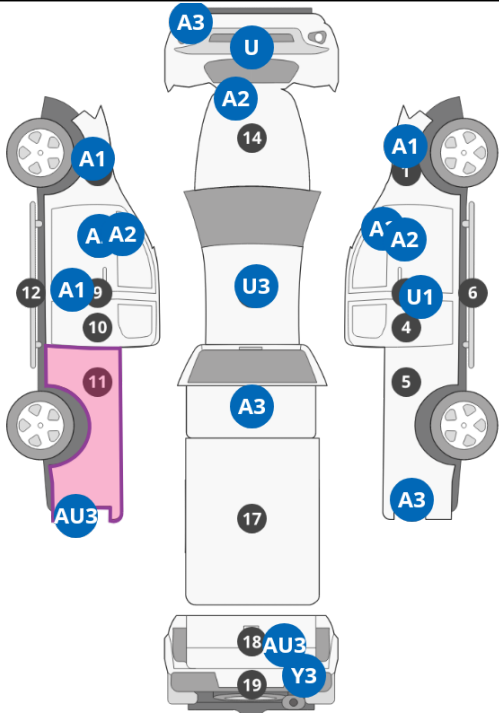
| Inspector Notes |
|---|
| with warranty booklet, no jack and tools, with spare tire, with LTO plate, scratched and cracked tail light |
