## General Information

| Make | Toyota | Model | Veloz |
| Registration No. | NJE4614 | Chassis No. | MHFAB1BY4R3117507 |

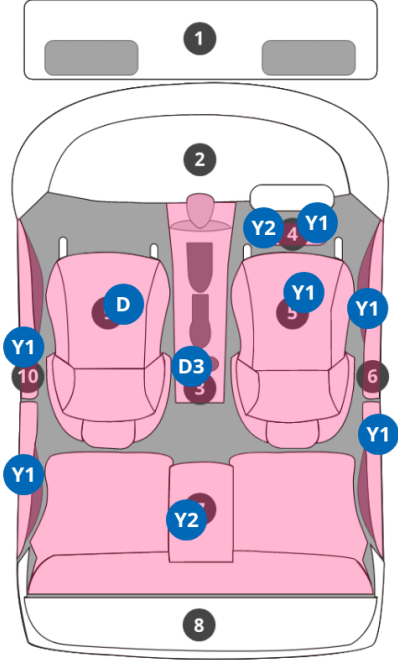
| Interior Evaluation : <b>B</b> | Exterior Evaluation : <b>E</b> |
|---|---|
| <p><b>Remarks</b></p> <p>Rear Seat - Grime - Small / (R) Front Trim - Grime - Minimal / (R) Front Floor Mat - Grime - Minimal / (R) Front Seat - Grime - Minimal / (R) Rear Trim - Grime - Minimal / (L) Rear Trim - Grime - Minimal / (L) Front Trim - Grime - Minimal / (L) Front Floor Mat - Grime - Small / (L) Front Seat - Worn - Yes / Console, Switches, Vents - Loose, Deformed - Medium</p> | <p><b>Remarks</b></p> <p>(L) Front Fender, Molding - Crack, Gap - Medium / Front Bumper, Grille, Lamps - Scratch &amp; Dent - Large / (L) Step, In-panel, Side Spoiler - Scratch - Small / (L) Front Door, Molding - Scratch - Minimal / (L) Rear Door, Molding - Scratch - Minimal / (L) Rear Fender, Molding - Scratch - Large / Trunk Hood, Rear Gate - Scratch - Minimal / Rear Bumper, Lamps, Panels - Scratch - Medium / (R) Rear Fender, Molding - Scratch - Minimal / (R) Rear Door, Molding - Scratch &amp; Dent - Small / (R) Step, In-panel, Side Spoiler - Scratch - Small / (R) Front Door, Molding - Scratch &amp; Dent - Large / (R) Mirror - Scratch - Medium / (R) Front Fender, Molding - Scratch - Minimal / Bonnet, Headlight - Scratch - Minimal / Roof - Scratch - Small / (L) Mirror - Scratch - Small</p> |

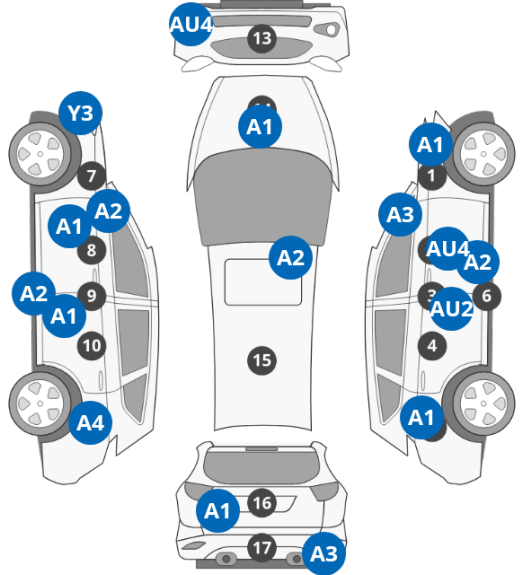
| Inspector Notes |
|---|
| <p>with LTO plate/no warranty booklet/with incomplete tools with jack/with spare tire/no spare key/with seat cover/maintenance warning lamp on/fog light issue/hairline scratches on the body</p> |
