## General Information

| Make | Toyota | Model | Vios |
| Registration No. | NKP6164 | Chassis No. | PA1B18F33S4287002 |

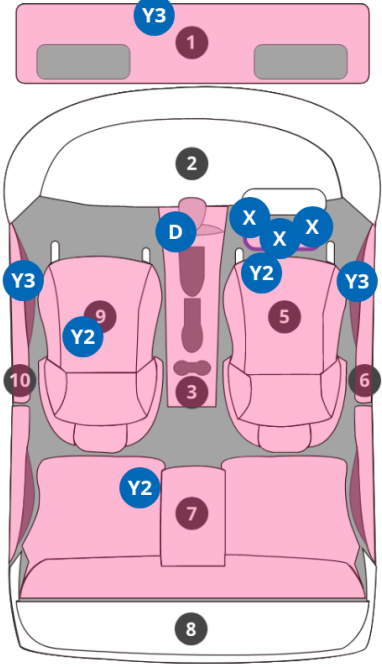
| Interior Evaluation : <b>C</b> | Exterior Evaluation : <b>E</b> |
|---|---|
| <p><b>Remarks</b><br/>(L) Front Floor Mat - Missing - Yes / (R) Front Floor Mat - Missing - Yes / Mat Other - Missing - Yes / (L) Front Trim - Grime - Medium / (R) Front Trim - Grime - Medium / Ceiling - Grime - Medium / (R) Front Seat - Grime - Small / (L) Front Seat - Grime - Small / Rear Seat - Grime - Small / Console, Switches, Vents - Traces of Adhesive Tape - Yes</p> | <p><b>Remarks</b><br/>(R) Front Fender - Repair Traces - Yes / Bonnet - Repair Traces - Yes / (L) Front Fender - Repair Traces - Yes / (L) Front Door - Repair Traces - Yes / (L) Rear Door - Repair Traces - Yes / (L) Rear Fender - Repair Traces - Yes / Trunk Hood, Rear Gate - Repair Traces - Yes / (R) Rear Door - Repair Traces - Yes / Roof - Repair Traces - Yes / Overall Exterior - Full Re-Paint in same color - Yes / (R) Front Fender, Molding - Repair mark - Yes / (R) Front Fender, Molding - Scratch - Minimal / (R) Mirror - Scratch - Minimal / (R) Front Door, Molding - Scratch - Minimal / (R) Step, In-panel, Side Spoiler - Scratch - Small / (R) Rear Door, Molding - Repair mark - Yes / (R) Rear Door, Molding - Scratch - Minimal / (R) Rear Fender, Molding - Repair mark - Yes / Rear Bumper, Lamps, Panels - Scratch - Small / Trunk Hood, Rear Gate - Repair mark - Yes / Trunk Hood, Rear Gate - Scratch - Small / Roof - Repair mark - Yes / (L) Rear Fender, Molding - Repair mark - Yes / (L) Rear Fender, Molding - Scratch - Minimal / (L) Rear Door, Molding - Repair mark - Yes / (L) Step, In-panel, Side Spoiler - Scratch - Small / (L) Front Door, Molding - Repair mark - Yes / (L) Rear Door, Molding - Scratch - Minimal / (L) Front Door, Molding - Scratch - Minimal / (L) Front Fender, Molding - Repair mark - Yes / (L) Front Fender, Molding - Scratch - Minimal / Bonnet, Headlight - Repair mark - Yes / Bonnet, Headlight - Scratch - Small / Front Bumper, Grille, Lamps - Repair mark - Yes / Front Bumper, Grille, Lamps - Scratch - Medium / Roof - Scratch - Small</p> |

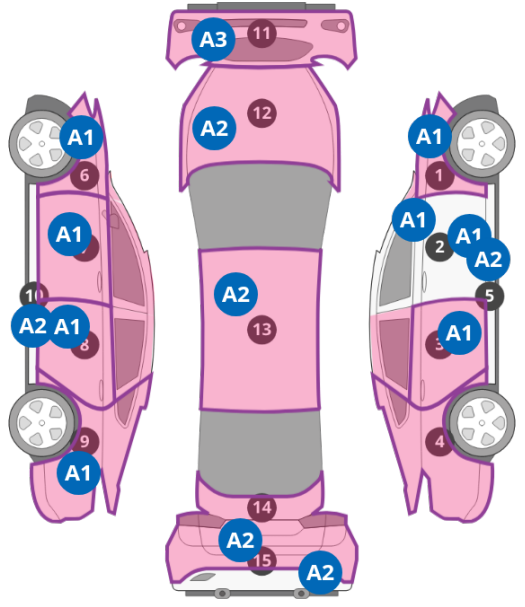
with lto plate/with warranty booklet/with reverse camera/with repainted body panels/with dent and scratches on the body/with modified sided mirror left side/without tools and jack/without spare key/with reverse camera
