## General Information

| Make | Toyota | Model | Vios |
| YOM | 2024 | Odo Meter Reading | 15,307 |
| Registration No. | DBM8201 | Chassis No. | PA1B18F30R4244179 |

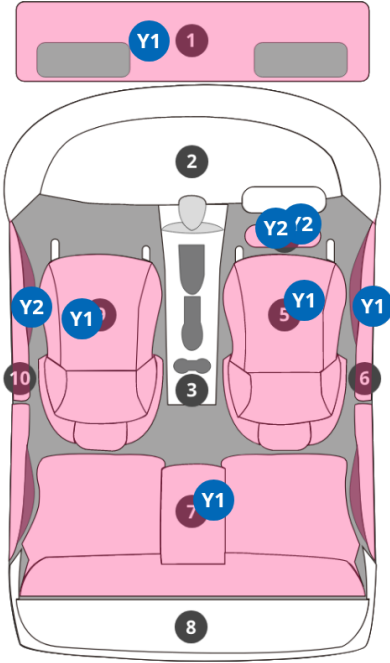
| Interior Evaluation : <b>B</b> | Exterior Evaluation : <b>C</b> |
|---|---|
| <p><b>Remarks</b><br/>(R) Front Floor Mat - Grime - Small / (L) Front Floor Mat - Grime - Small / (L) Front Seat - Grime - Minimal / Rear Seat - Grime - Minimal / (R) Front Seat - Grime - Minimal / (L) Front Trim - Grime - Small / (R) Front Trim - Grime - Minimal / Ceiling - Grime - Minimal</p> | <p><b>Remarks</b><br/>(L) Front Fender - Repair Traces - Yes / (L) Rear Fender, Molding - Scratch &amp; Dent - Minimal / (L) Rear Door, Molding - Scratch &amp; Dent - Minimal / (L) Front Door, Molding - Scratch &amp; Dent - Minimal / Roof - Scratch &amp; Dent - Minimal / (L) Step, In-panel, Side Spoiler - Scratch - Minimal / (L) Front Fender, Molding - Scratch &amp; Dent - Small / Bonnet, Headlight - Scratch &amp; Dent - Small / Front Bumper, Grille, Lamps - Scratch - Medium / (R) Front Fender, Molding - Scratch &amp; Dent - Minimal / (R) Step, In-panel, Side Spoiler - Scratch - Medium / (R) Rear Door, Molding - Scratch &amp; Dent - Small / (R) Rear Fender, Molding - Scratch - Medium / Rear Bumper, Lamps, Panels - Scratch - Small / Trunk Hood, Rear Gate - Scratch &amp; Dent - Small</p> |

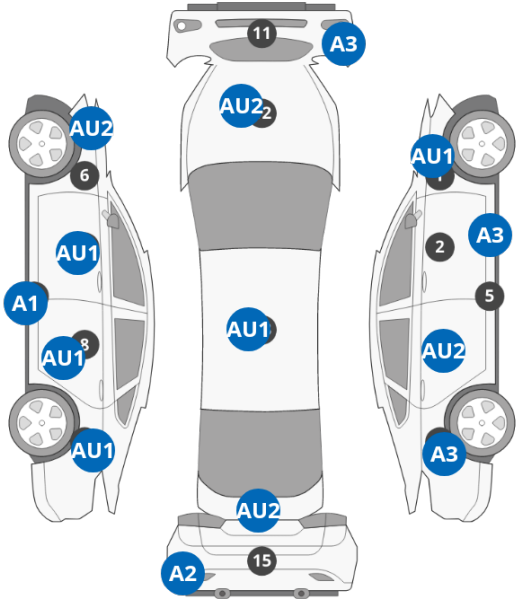
| Inspector Notes |
|---|
| with LTO plate, with jack and inc tools, with spare tire, with manual and warranty booklet, with reverse camera, no spare key, scratches and dent on exterior, scratches in taillight and headlight. |
