## General Information

| Make | Toyota | Model | Vios |

## Body / Panel Condition

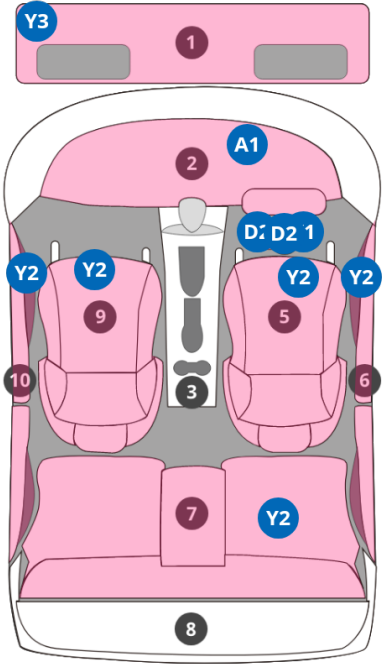
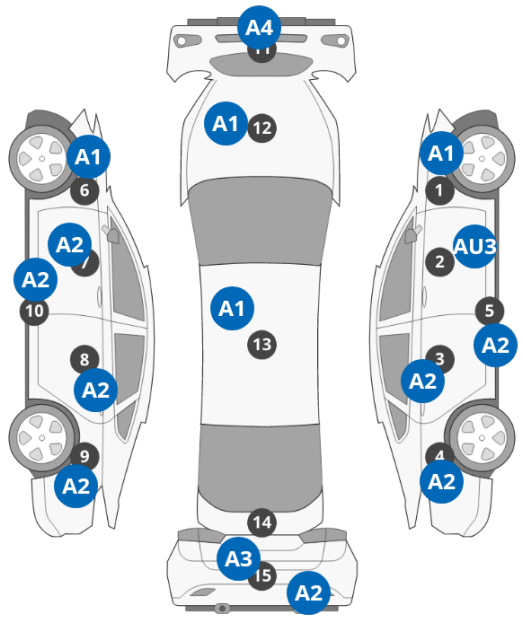
| Interior Evaluation : <b>C</b> | Exterior Evaluation : <b>D</b> |
|---|---|
| <p><b>Remarks</b><br/>(L) Front Trim - Grime - Small / (R) Front Trim - Grime - Small / (L) Front Floor Mat - Worked - Small / (R) Front Floor Mat - Grime - Minimal / (L) Front Seat - Grime - Small / (R) Front Seat - Grime - Small / Mat Other - Worked - Small / Rear Seat - Grime - Small / Ceiling - Grime - Medium / Dashboard - Worn, Scratch, Cut, Crack - Minimal</p> | <p><b>Remarks</b><br/>(R) Front Fender, Molding - Scratch - Minimal / (R) Front Door, Molding - Scratch &amp; Dent - Medium / (R) Rear Door, Molding - Scratch - Small / (R) Rear Fender, Molding - Scratch - Small / Trunk Hood, Rear Gate - Scratch - Medium / Rear Bumper, Lamps, Panels - Scratch - Small / (L) Rear Fender, Molding - Scratch - Small / (L) Rear Door, Molding - Scratch - Small / (L) Front Door, Molding - Scratch - Small / (L) Step, In-panel, Side Spoiler - Scratch - Small / (L) Front Fender, Molding - Scratch - Minimal / (R) Step, In-panel, Side Spoiler - Scratch - Small / Front Bumper, Grille, Lamps - Scratch - Large / Bonnet, Headlight - Scratch - Minimal / Roof - Scratch - Minimal</p> |
