## General Information

| Make | Toyota | Model | Vios |
| YOM | 2024 | Mileage | 18,603 |
| Registration No. | DBM2606 | Chassis No. | PA1B18F33R4240787 |

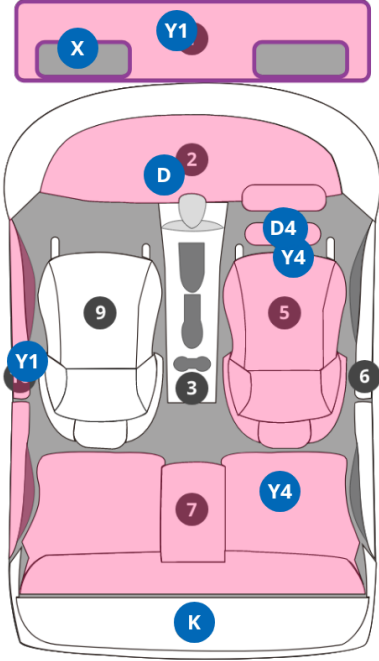
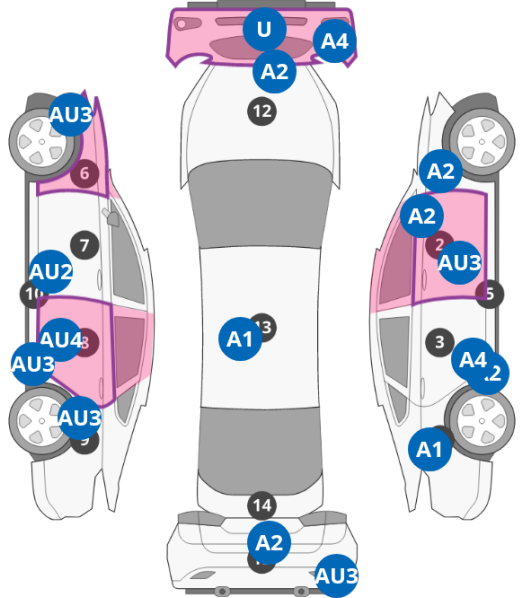
| Interior Evaluation : <b>C</b> | Exterior Evaluation : <b>E</b> |
|---|---|
| <p><b>a</b> : Cut, Fray <b>d</b> : Loose, Deformed <b>k</b> : Animal Hair <b>s</b> : Smell <b>t</b> : Cigarette Burns <b>x</b> : Defective <b>y</b> : Stain</p> | <p><b>A</b> : Scratch <b>AU</b> : Scratch &amp; Dent <b>B</b> : Modified <b>C</b> : Corrosion <b>G</b> : Stone chip <b>P</b> : Faded <b>S</b> : Rust <b>SC</b> : Rust &amp; Corrosion <b>U</b> : Dent <b>X</b> : Defective <b>Y</b> : Crack, Gap</p> |
| <p><b>Remarks</b></p> <p>Rear Seat - Grime - Large / (R) Front Seat - Grime - Large / Mat Other - Grime - Small / (L) Front Floor Mat - Cut, Crack - Small / (L) Front Floor Mat - Worked - Large / Dashboard - Traces of Adhesive Tape - Yes / Sunvisor, Sunglass Holder - Missing - Yes / Ceiling - Grime - Minimal / (L) Front Trim - Grime - Minimal / Overall Interior - Animal Hair - Yes</p> | <p><b>Remarks</b></p> <p>(R) Mirror - Scratch - Small / (R) Front Fender, Molding - Scratch - Small / (R) Front Door, Molding - Repair mark - Yes / (R) Front Door, Molding - Scratch &amp; Dent - Medium / (R) Step, In-panel, Side Spoiler - Scratch - Small / (R) Rear Door, Molding - Scratch - Large / Trunk Hood, Rear Gate - Scratch - Small / Rear Bumper, Lamps, Panels - Scratch &amp; Dent - Medium / (R) Rear Fender, Molding - Scratch - Minimal / (L) Rear Fender, Molding - Scratch &amp; Dent - Medium / (L) Rear Door, Molding - Repair mark - Yes / (L) Rear Door, Molding - Scratch &amp; Dent - Large / (L) Step, In-panel, Side Spoiler - Scratch &amp; Dent - Medium / (L) Front Door, Molding - Scratch &amp; Dent - Small / (L) Front Fender, Molding - Repair mark - Yes / (L) Front Fender, Molding - Scratch &amp; Dent - Medium / Member (Bolted) - Dent - Yes / Front Bumper, Grille, Lamps - Repair mark - Yes / Front Bumper, Grille, Lamps - Scratch - Large / Bonnet, Headlight - Scratch - Small / Roof - Scratch - Minimal</p> |
