## General Information

| Make | Toyota | Model | Vios |
| Registration No. | NFR9768 | Chassis No. | PA1B18F37R4258497 |

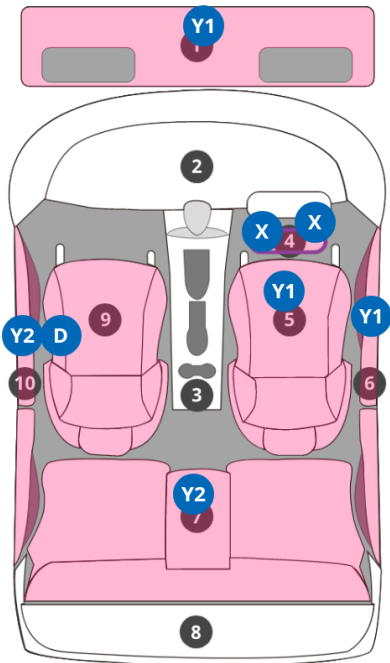
| Interior Evaluation : <b>B</b> | Exterior Evaluation : <b>B</b> |
|---|---|
| <b>Remarks</b><br>(R) Front Floor Mat - Missing - Yes / (L) Front Floor Mat - Missing - Yes / Rear Seat - Grime - Small / (R) Front Seat - Grime - Minimal / (R) Front Trim - Grime - Minimal / (L) Front Trim - Grime - Small / (L) Front Seat - Worn - Yes / Ceiling - Grime - Minimal | <b>Remarks</b><br>(L) Front Fender, Molding - Scratch - Minimal / (L) Step, In-panel, Side Spoiler - Scratch - Small / (L) Front Door, Molding - Scratch & Dent - Minimal / (L) Rear Door, Molding - Scratch - Minimal / (L) Rear Fender, Molding - Scratch - Minimal / Trunk Hood, Rear Gate - Scratch - Minimal / Rear Bumper, Lamps, Panels - Scratch - Small / (R) Rear Fender, Molding - Scratch - Minimal / (R) Rear Door, Molding - Scratch - Minimal / (R) Step, In-panel, Side Spoiler - Scratch - Small / (R) Front Door, Molding - Scratch - Minimal / (R) Front Fender, Molding - Scratch - Minimal / Bonnet, Headlight - Scratch - Small / Front Bumper, Grille, Lamps - Scratch - Small / Roof - Scratch - Minimal |

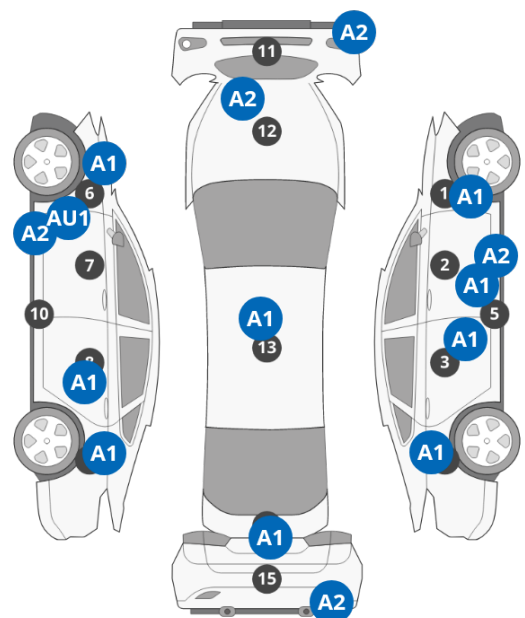
with LTO plate/with warranty booklet/no tools with jack/with spare tire/no spare key/hairline scratches on the body
