## General Information

| Make | Toyota | Model | Vios |
| Registration No. | NEY8110 | Chassis No. | PA1B28F37R4266731 |

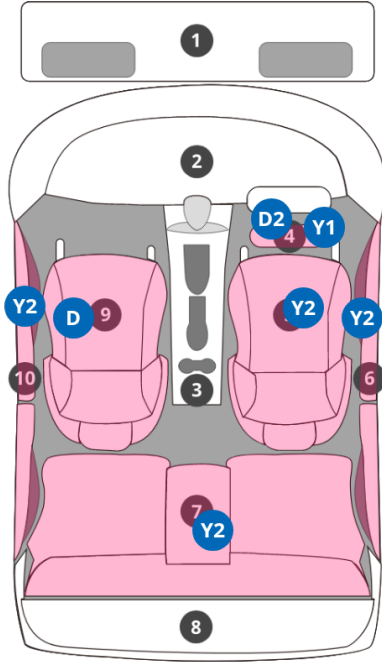
| Interior Evaluation : <b>B</b> | Exterior Evaluation : <b>D</b> |
|---|---|
| <b>Remarks</b><br>Rear Seat - Grime - Small / (R) Front Trim - Grime - Small / (R) Front Floor Mat - Grime - Minimal / (R) Front Seat - Grime - Small / (L) Front Seat - Worn - Yes / (L) Front Trim - Grime - Small / (L) Front Floor Mat - Worked - Small | <b>Remarks</b><br>(L) Front Fender, Molding - Scratch - Small / (L) Step, In-panel, Side Spoiler - Scratch - Small / (L) Front Door, Molding - Scratch - Small / (L) Rear Door, Molding - Scratch - Small / (L) Rear Fender, Molding - Scratch - Small / Trunk Hood, Rear Gate - Scratch - Small / Rear Bumper, Lamps, Panels - Scratch - Medium / (R) Rear Fender, Molding - Scratch - Small / (R) Step, In-panel, Side Spoiler - Scratch - Small / (R) Rear Door, Molding - Scratch - Small / (R) Front Door, Molding - Scratch - Small / (R) Front Fender, Molding - Scratch - Minimal / Front Bumper, Grille, Lamps - Scratch - Medium / Bonnet, Headlight - Scratch - Small / Roof - Scratch - Small |

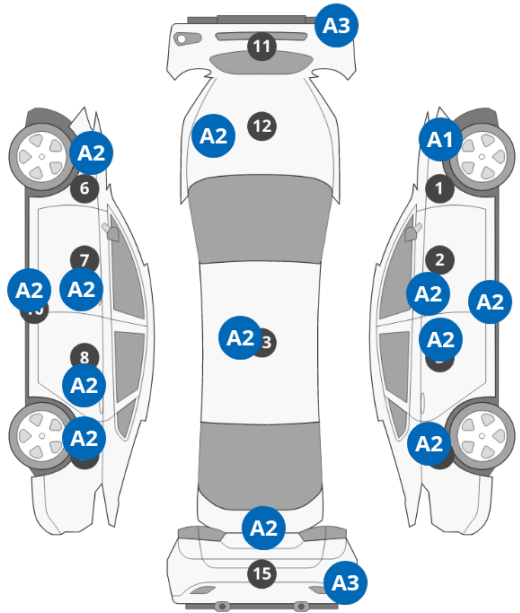
with LTO plate/no warranty booklet/with incomplete tools with jack/with spare tire/no spare key/with seat cover/hairline scratches on the body/traces of adhesive on exterior/scratches on taillight cover
