## General Information

| Make | Toyota | Model | Vios |
| YOM | 2025 | Odo Meter Reading | 10,417 |
| Registration No. | DBR1666 | Chassis No. | PA1B18F30R4274458 |

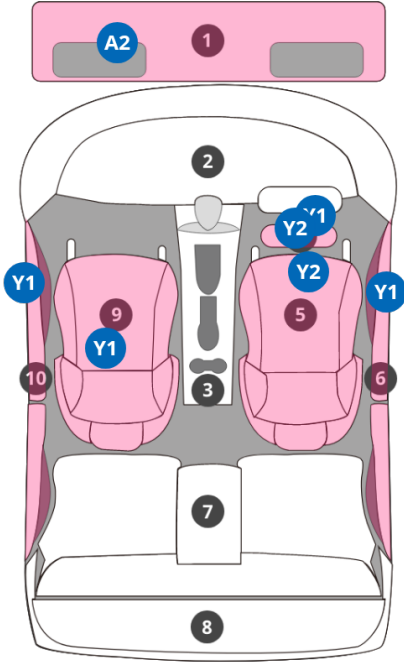
| Interior Evaluation : <b>B</b> | Exterior Evaluation : <b>B</b> |
|---|---|
| <p><b>Remarks</b><br/>(R) Front Seat - Grime - Small / (L) Front Seat - Grime - Minimal / (R) Front Floor Mat - Grime - Minimal / (L) Front Floor Mat - Grime - Small / (L) Front Trim - Grime - Minimal / (R) Front Trim - Grime - Minimal / Sunvisor, Sunglass Holder - Cut, Crack - Small</p> | <p><b>Remarks</b><br/>(R) Front Fender - Repair Traces - Yes / Bonnet - Repair Traces - Yes / (L) Front Fender - Repair Traces - Yes / Bonnet, Headlight - Scratch &amp; Dent - Small / (L) Front Fender, Molding - Scratch &amp; Dent - Minimal / Roof - Scratch &amp; Dent - Small / (L) Front Door, Molding - Scratch &amp; Dent - Minimal / (L) Rear Door, Molding - Scratch &amp; Dent - Minimal / Trunk Hood, Rear Gate - Scratch - Small / (R) Rear Fender, Molding - Scratch &amp; Dent - Minimal / (R) Step, In-panel, Side Spoiler - Scratch &amp; Dent - Minimal / (R) Front Door, Molding - Scratch &amp; Dent - Minimal / (R) Rear Door, Molding - Scratch &amp; Dent - Small / (R) Front Fender, Molding - Scratch &amp; Dent - Minimal / Rear Bumper, Lamps, Panels - Scratch - Small / Front Bumper, Grille, Lamps - Scratch - Minimal / (L) Rear Fender, Molding - Scratch &amp; Dent - Minimal / (R) Rear Fender, Molding - Repair mark - Yes</p> |

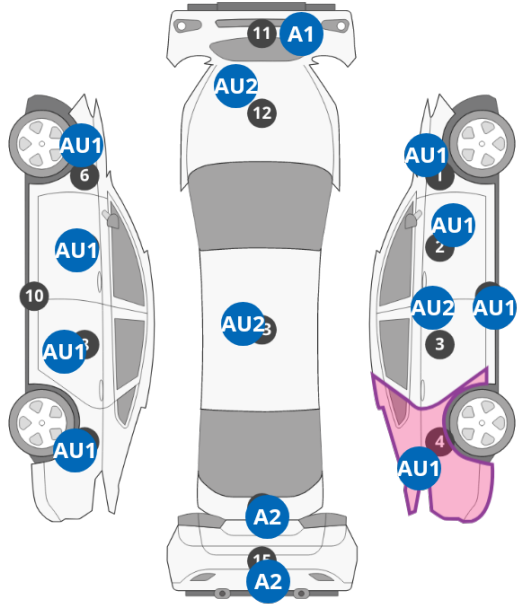
| Inspector Notes |
|---|
| with LTO plate, with spare tire, with reverse camera, with manual and warranty booklet, with jack, minor scratches and dent on exterior, scratches in taillight and headlight, no spare key. |
