## General Information

| Make | Toyota | Model | Vios |

## Body / Panel Condition

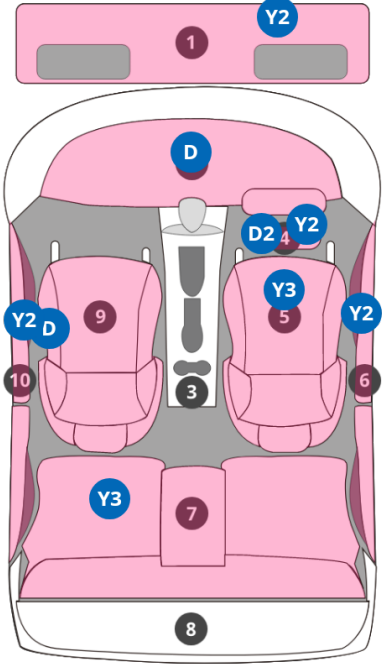
| Interior Evaluation : <b>C</b> | Exterior Evaluation : <b>E</b> |
| <p><b>Remarks</b></p> <p>(L) Front Seat - Worn - Yes / (L) Front Floor Mat - Worked - Small / (R) Front Floor Mat - Grime - Small / (R) Front Seat - Grime - Medium / (L) Front Trim - Grime - Small / (R) Front Trim - Grime - Small / Ceiling - Grime - Small / Rear Seat - Grime - Medium / Dashboard - Traces of Adhesive Tape - Yes</p> | <p><b>Remarks</b></p> <p>Bonnet - Repair Traces - Yes / (R) Front Fender, Molding - Scratch - Small / (R) Mirror - Scratch - Minimal / (R) Rear Door, Molding - Scratch &amp; Dent - Large / (R) Rear Fender, Molding - Scratch &amp; Dent - Large / (R) Front Door, Molding - Scratch &amp; Dent - Small / Rear Bumper, Lamps, Panels - Scratch &amp; Dent - Large / Trunk Hood, Rear Gate - Scratch &amp; Dent - Large / (L) Rear Fender, Molding - Scratch - Medium / (L) Rear Door, Molding - Scratch - Small / (L) Front Door, Molding - Scratch - Small / (L) Mirror - Scratch - Minimal / (L) Front Fender, Molding - Partially Missing - Yes / (L) Front Fender, Molding - Scratch - Small / Member (Bolted) - Dent - Yes / Front Bumper, Grille, Lamps - Scratch &amp; Dent - Large / Bonnet, Headlight - Scratch - Large / Roof - Scratch - Small</p> |

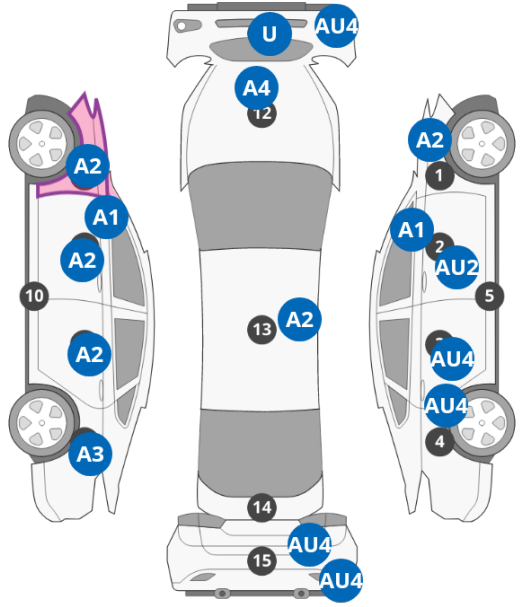
| Inspector Notes |
|---|
| <p>with warranty booklet, no jack and tools, with spare tire, with LTO plate, scratches on tail light, trunk room floor cardboard missing, rear bumper reflectorize tail light partially missing, front left fender liner missing, plate light issue</p> |
