## General Information

| Make | Toyota | Model | Vios |
| Registration No. | VAC6108 | Chassis No. | PA1B18F3XS4306435 |

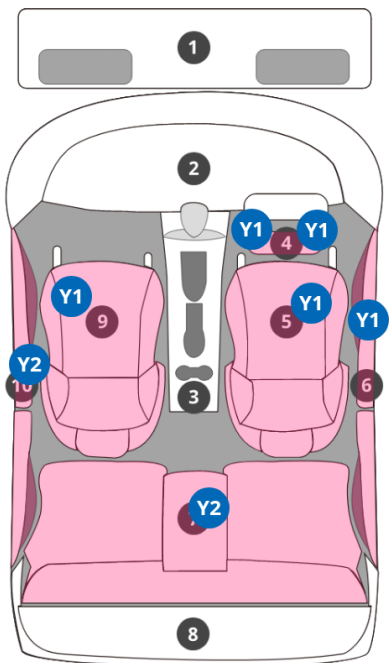
| Interior Evaluation : <span style="color: red; font-weight: bold;">A</span> | | Exterior Evaluation : <span style="color: red; font-weight: bold;">B</span> | |
|---|--|---|--|
| <p><b>Remarks</b></p> <p>Rear Seat - Grime - Small / (R) Front Trim - Grime - Minimal / (R) Front Floor Mat - Grime - Minimal / (L) Front Trim - Grime - Small / (R) Front Seat - Grime - Minimal / (L) Front Seat - Grime - Minimal / (L) Front Floor Mat - Grime - Minimal</p> | | <p><b>Remarks</b></p> <p>(L) Front Fender, Molding - Scratch - Small / (L) Mirror - Scratch - Minimal / (L) Step, In-panel, Side Spoiler - Scratch - Small / (L) Front Door, Molding - Scratch - Minimal / (L) Rear Fender, Molding - Scratch - Minimal / Trunk Hood, Rear Gate - Scratch - Minimal / Rear Bumper, Lamps, Panels - Scratch - Minimal / (R) Rear Fender, Molding - Scratch - Minimal / (R) Rear Door, Molding - Scratch - Minimal / (R) Step, In-panel, Side Spoiler - Scratch &amp; Dent - Medium / (R) Front Door, Molding - Scratch - Minimal / (R) Front Fender, Molding - Scratch - Minimal / Front Bumper, Grille, Lamps - Scratch - Minimal / Bonnet, Headlight - Scratch - Minimal / Roof - Scratch - Small</p> | |
