## General Information

| Make | Toyota | Model | Vios |
| YOM | 2025 | Odo Meter Reading | 30,218 |
| Registration No. | NJF7328 | Chassis No. | PA1B18F39S4286971 |

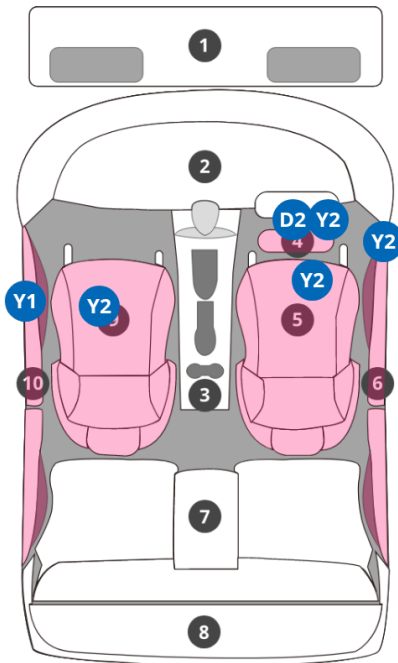
| Interior Evaluation : <b>B</b> | Exterior Evaluation : <b>C</b> |
|---|---|
| <p><b>Remarks</b></p> <p>(R) Front Floor Mat - Grime - Small / (L) Front Floor Mat - Crinkle - Small / (L) Front Seat - Grime - Small / (R) Front Seat - Grime - Small / (L) Front Trim - Grime - Minimal / (R) Front Trim - Grime - Small</p> | <p><b>Remarks</b></p> <p>(R) Front Fender - Repair Traces - Yes / Bonnet - Repair Traces - Yes / (L) Front Fender - Repair Traces - Yes / Trunk Hood, Rear Gate - Scratch &amp; Dent - Minimal / Rear Bumper, Lamps, Panels - Scratch &amp; Dent - Minimal / (L) Rear Fender, Molding - Dent - Small / Roof - Scratch &amp; Dent - Minimal / (L) Rear Door, Molding - Scratch &amp; Dent - Small / (L) Front Door, Molding - Scratch &amp; Dent - Small / (L) Front Fender, Molding - Scratch &amp; Dent - Minimal / Front Bumper, Grille, Lamps - Scratch &amp; Dent - Medium / (R) Front Fender, Molding - Scratch &amp; Dent - Medium / (R) Front Door, Molding - Scratch &amp; Dent - Small / Bonnet, Headlight - Scratch &amp; Dent - Small / (R) Rear Door, Molding - Scratch &amp; Dent - Small / (R) Step, In-panel, Side Spoiler - Modified - Small / (R) Rear Fender, Molding - Scratch &amp; Dent - Small / (L) Step, In-panel, Side Spoiler - Scratch &amp; Dent - Small</p> |

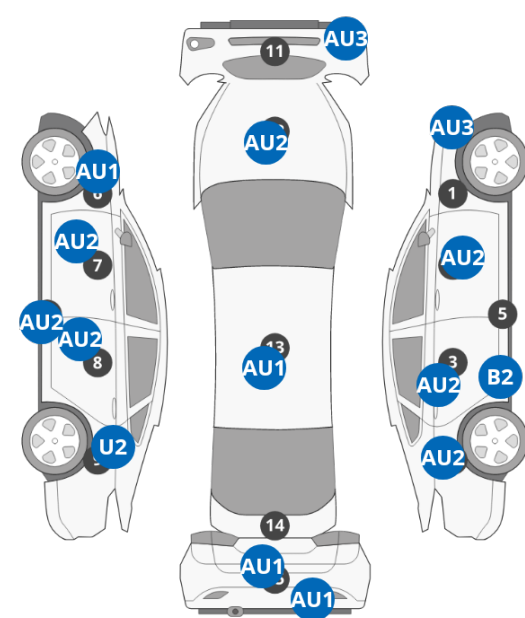
| Inspector Notes |
|---|
| <p>with LTO plate, with tools, with warranty booklet, with reverse camera, no spare key and tire, no warranty booklet, no jack, scratches and dent on exterior, scratches in taillight and headlight.</p> |
